ENVIRONMENTAL TEST REPORT 1608-019NB-1 REV. N/C

TEST STANDARDS: MIL-STD-810G

STILETTO AL (4 METER TELESCOPING MAST)

PERFORMED BY: KEYSTONE COMPLIANCE, LLC.
131 COLUMBUS INNER BELT
NEW CASTLE, PA 16101

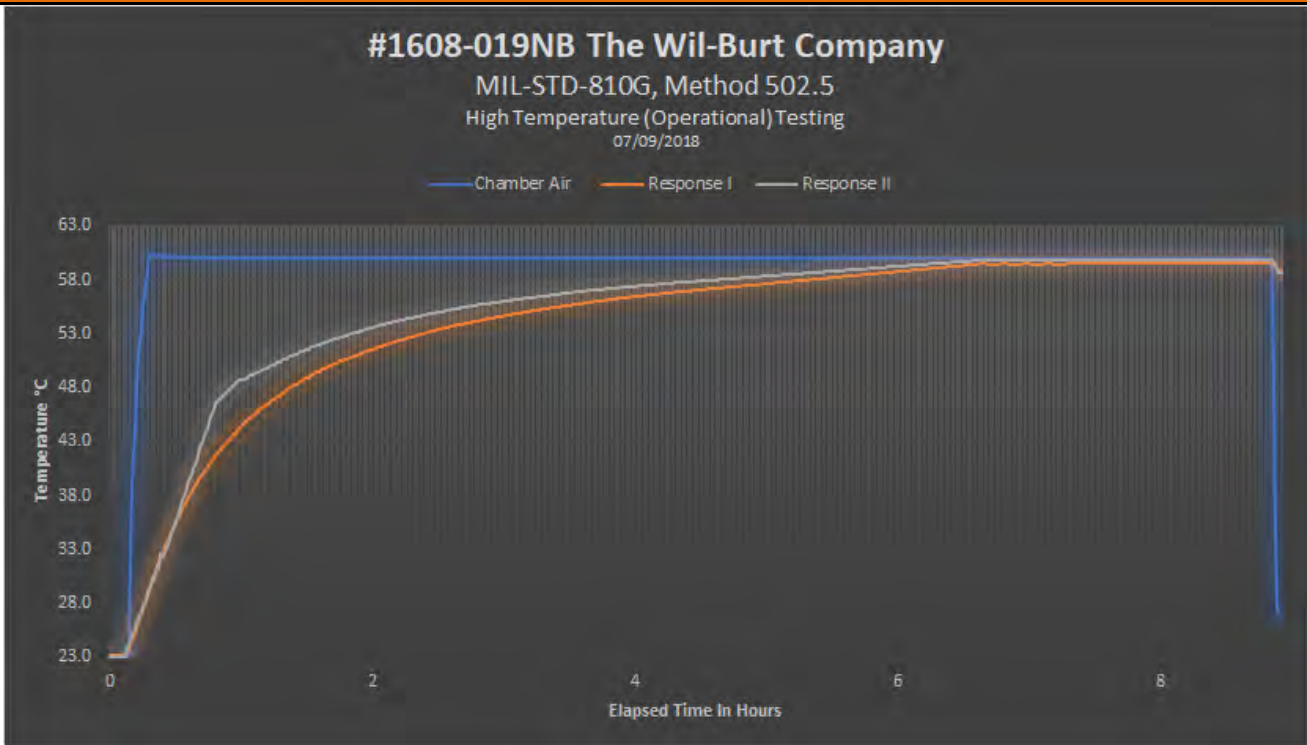
<p>#1608-019NB The Wil-Burt Company MIL-STD-810G, Method 502.5 High Temperature (Operational) Testing 07/09/2018</p> <p>— Chamber Air — Response I — Response II</p>											
Environmental Profile Information											
Test Cycle Begins At:	07:49 on 07/09/2018										
Test Cycle Ends At:	16:44 on 07/09/2018										
Total Number of Cycles:	1										
Cycle Duration:	2 hours after temperature stabilization is reached										
EUT Test Information			Y	N	N/A	Comments					
Operating During Test:				X		Operating Mode:	N/A				
Powered During Test:				X		V	N/A	A	N/A	AC/DC	N/A

Physical Damage Noted:				X		Units were all tested (functionally), after soaking 2 hours at 60°C.					
PAGE: 1	ENGINEER/TECHNICIAN(S): T. Swartz										
OF: 1	TECHNICAL REVIEWER: R. Turner

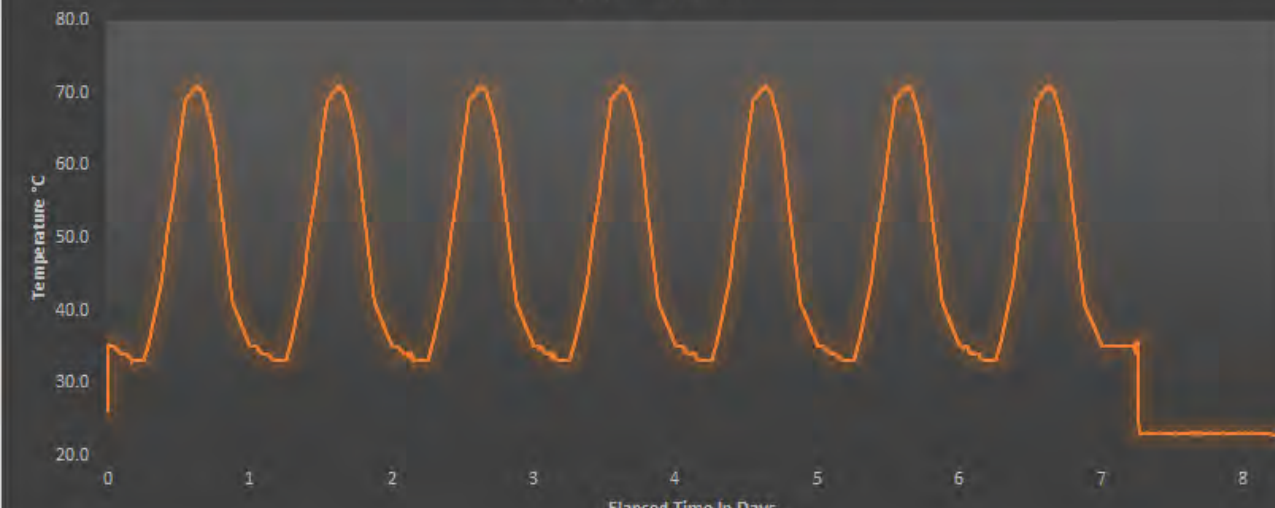
<p>The graph displays a repeating temperature profile over an 8-day period. The y-axis represents Temperature in degrees Celsius, ranging from 20.0 to 80.0. The x-axis represents Elapsed Time in Days, ranging from 0 to 8. The profile shows 7 distinct cycles, each starting at approximately 35°C, rising to a peak of about 70°C, and then falling back to the starting temperature. After the 7th cycle, the temperature drops to a constant level of approximately 23°C.</p>

Environmental Profile Information											
Test Cycle Begins At:	09:43 on 06/21/2018										
Test Cycle Ends At:	15:46 on 06/29/2018										
Total Number of Cycles:	7										
Cycle Duration:	24 Hours										
EUT Test Information			Y	N	N/A	Comments					
Operating During Test:				X		Operating Mode: N/A					
Powered During Test:				X		V	N/A	A	N/A	AC/DC	N/A
Physical Damage Noted:				X		Units were all tested (functionally) at the completion of the 7 th cycle (35°C), and again after testing was completed at ambient (23°).					
PAGE: 1	ENGINEER/TECHNICIAN(s): T. Swartz										
OF: 1	TECHNICAL REVIEWER: R. Turner

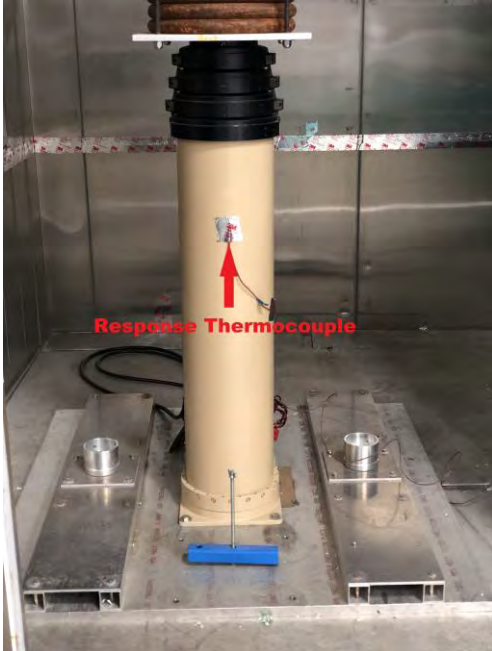
High Temperature	
	MIL-STD-810G	
	Response Location	
	Unit Tested	Stiletto AL (4 Meter Telescoping Mast)
	Model Number	N/A
	Part Number	N/A
	Serial Number	N/A
	Will-Burt Company	
	Date:	6/21/18 - 6/29/18
	Job #:	1608-019NB-1

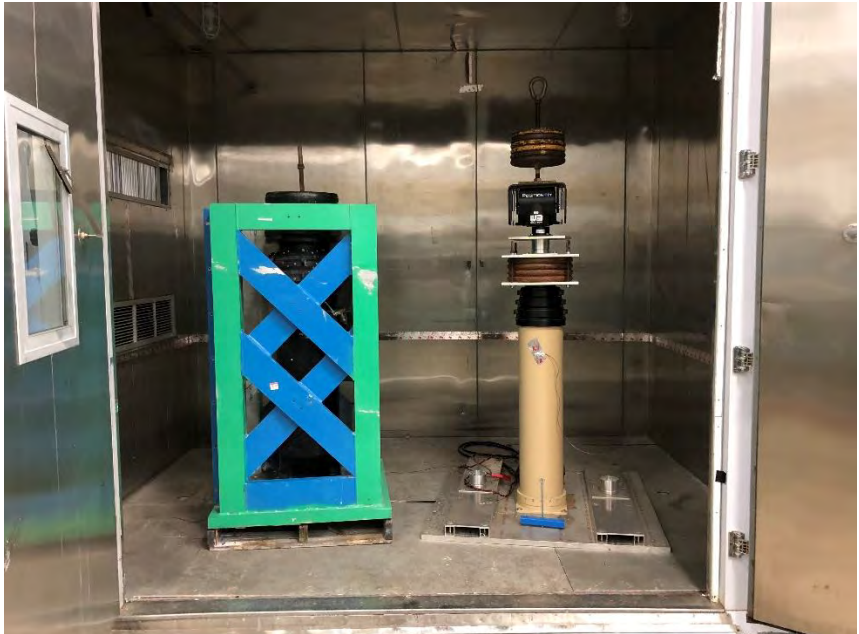
High Temperature	
	MIL-STD-810G	
	Post Test (Pre-Functional Check)	
	Unit Tested	Stiletto AL (4 Meter Telescoping Mast)
	Model Number	N/A
	Part Number	N/A
	Serial Number	N/A
	Will-Burt Company	
	Date:	6/21/18 - 6/29/18
	Job #:	1608-019NB-1

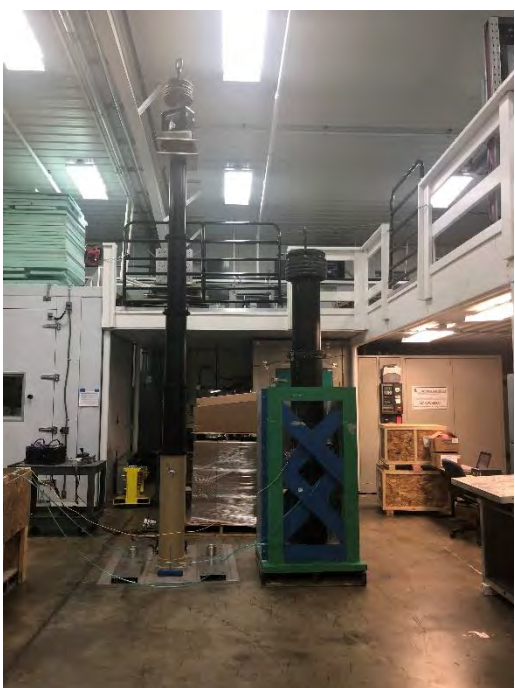
High Temperature	
	MIL-STD-810G	
	Post Operating Functional Verification	
	Unit Tested	Stiletto AL (4 Meter Telescoping Mast)
	Model Number	N/A
	Part Number	N/A
	Serial Number	N/A
	Will-Burt Company	
	Date:	6/21/18 - 6/29/18
	Job #:	1608-019NB-1

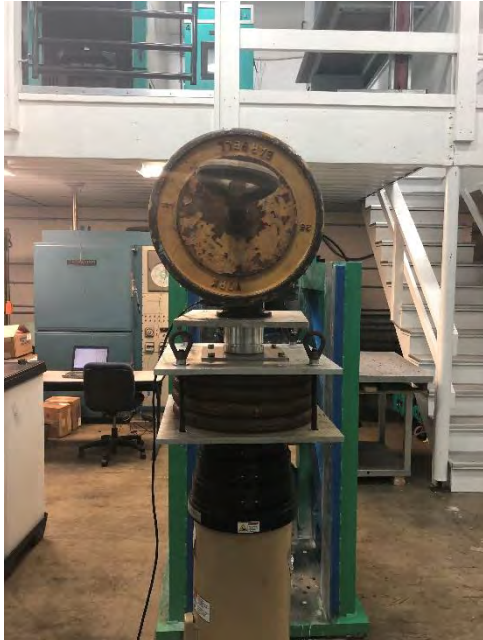
High Temperature	
	MIL-STD-810G	
	Post Operating Functional Verification	
	Unit Tested	Stiletto AL (4 Meter Telescoping Mast)
	Model Number	N/A
	Part Number	N/A
	Serial Number	N/A
	Will-Burt Company	
	Date:	6/21/18 - 6/29/18
	Job #:	1608-019NB-1

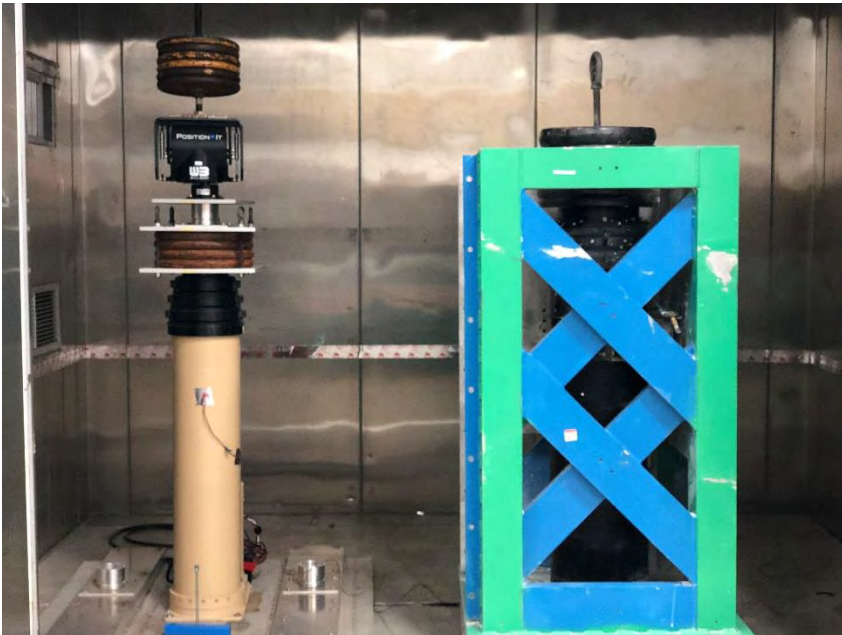
High Temperature	
	MIL-STD-810G	
	Storage Test Setup	
	Unit Tested	Stiletto AL (4 Meter Telescoping Mast)
	Model Number	N/A
	Part Number	N/A
	Serial Number	N/A
	Will-Burt Company	
	Date:	6/21/18 - 6/29/18
	Job #:	1608-019NB-1

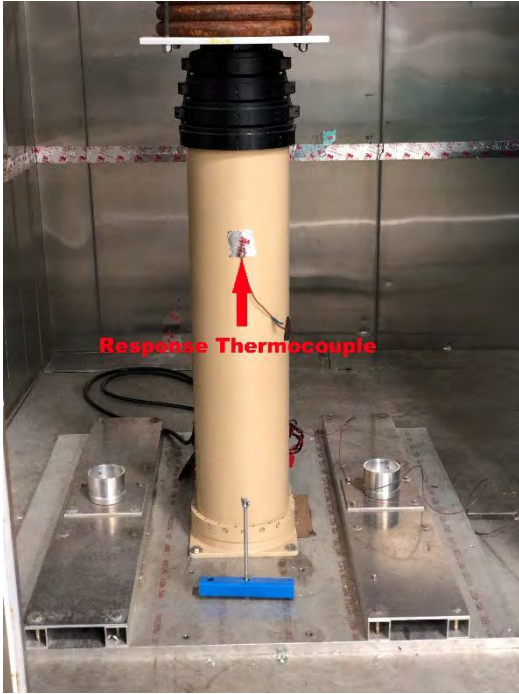
High Temperature	
	MIL-STD-810G	
	Response Location	
	Unit Tested	Stiletto AL (4 Meter Telescoping Mast)
	Model Number	N/A
	Part Number	N/A
	Serial Number	N/A
	Will-Burt Company	
	Date:	6/21/18 - 6/29/18
	Job #:	1608-019NB-1

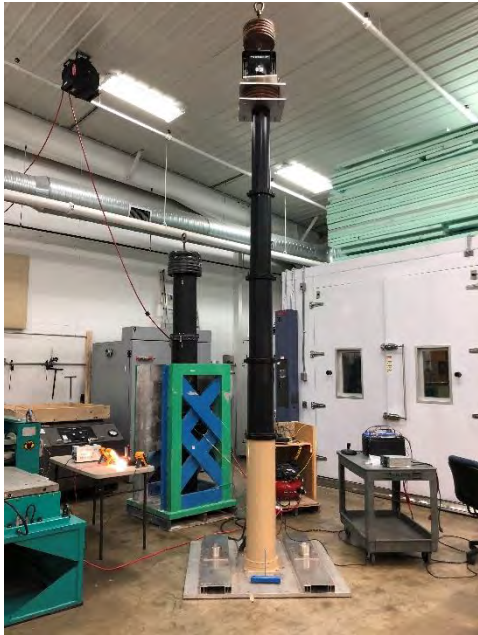
High Temperature	
	MIL-STD-810G	
	Post Storage Functional Verification	
	Unit Tested	Stiletto AL (4 Meter Telescoping Mast)
	Model Number	N/A
	Part Number	N/A
	Serial Number	N/A
	Will-Burt Company	
	Date:	6/21/18 - 6/29/18
	Job #:	1608-019NB-1

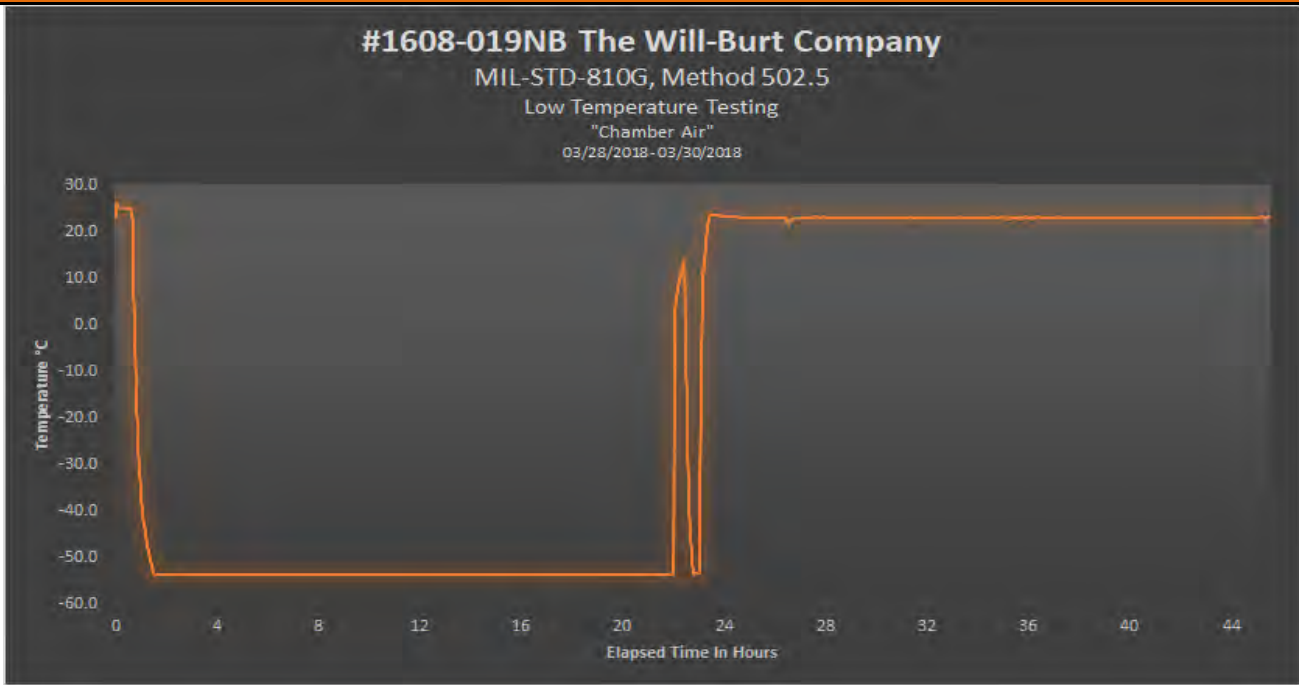
#1608-019NB The Will-Burt Company MIL-STD-810G, Method 502.5 Low Temperature Testing "Chamber Air" 03/28/2018 - 03/30/2018

Environmental Profile Information					
Test Cycle Begins At:	11:25 on 03/28/2018				
Test Cycle Ends At:	08:47 on 03/30/2018				
Total Number of Cycles:	1				
Target Temperature:	-51°C				
Cycle Duration:	UUT's to be soaked a minimum of two hours once the testing chamber stabilizes at target.				
EUT Test Information	Y	N	N/A	Comments	
Operating During Test:	X			Operating Mode:	Powered On for functional evaluation.
Powered During Test:	X			V	12.6 A AC/DC DC
Physical Damage Noted:		X		One unit is pneumatic powered, and the other units are DC powered.	
PAGE: 1	ENGINEER/TECHNICIAN(s): T. Swartz				
OF: 2	TECHNICAL REVIEWER: R. Turner

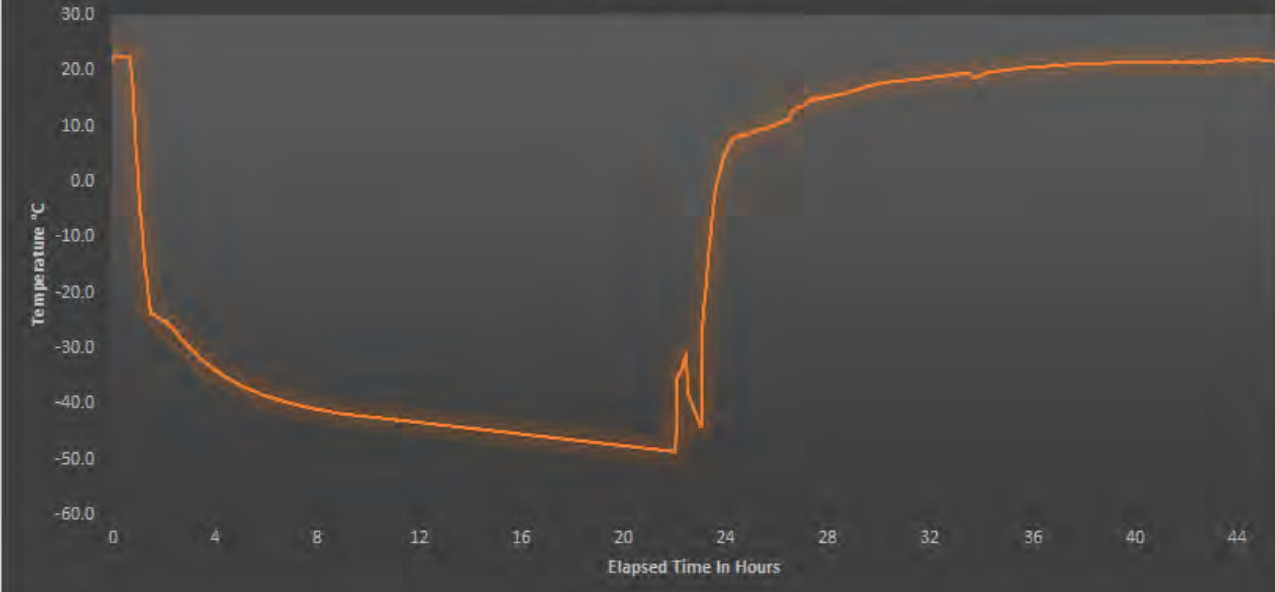
Low Temperature Data Sheet			
EUT:	Stiletto AL (4 Meter Telescoping Mast)		Job Number: 1608-019NB-1
M/N:	N/A	P/N: N/A	S/N: N/A
Customer:	Will-Burt Company		
Date:	3/28/18 - 3/30/18		Test Engineer: T. Swartz
Test Specifications			
Test Spec.:	MIL-STD-810G		Para./Sec.: 502.5
Response Profile			
<p>#1608-019NB The Will-Burt Company MIL-STD-810G, Method 502.5 Low Temperature Testing "Response" 03/28/2018 - 03/30/2018</p>

Environmental Profile Information			
Test Cycle Begins At:	11:25 on 03/28/2018		
Test Cycle Ends At:	08:47 on 03/30/2018		
Total Number of Cycles:	1		
Target Temperature:	-51°C		
Cycle Duration:	UUT's to be soaked a minimum of two hours once the testing chamber stabilizes at target.

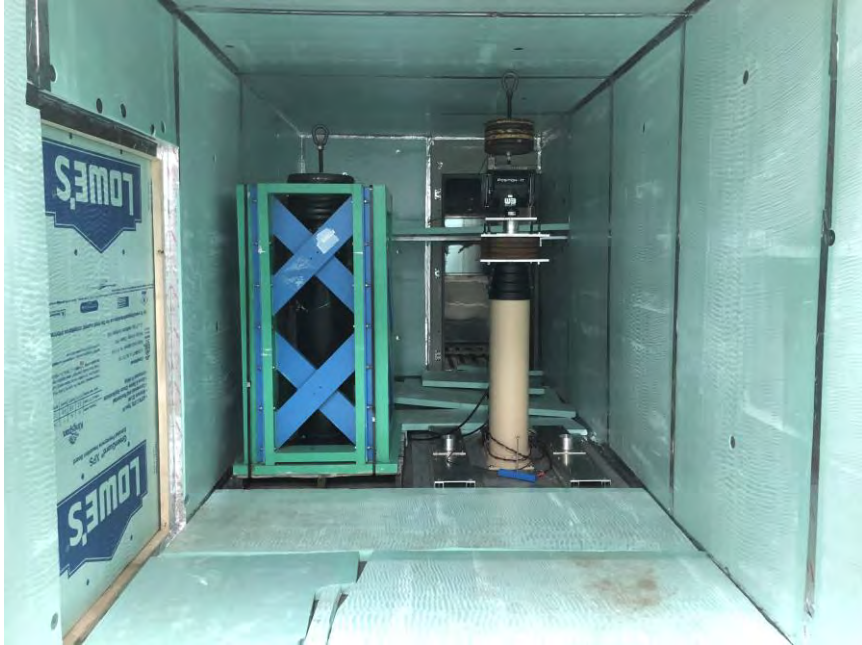
Low Temperature	
	MIL-STD-810G	
	Test Setup	
	Unit Tested	Stiletto AL (4 Meter Telescoping Mast)
	Model Number	N/A
	Part Number	N/A
	Serial Number	N/A
	Will-Burt Company	
	Date:	3/28/18 - 3/30/18
	Job #:	1608-019NB-1

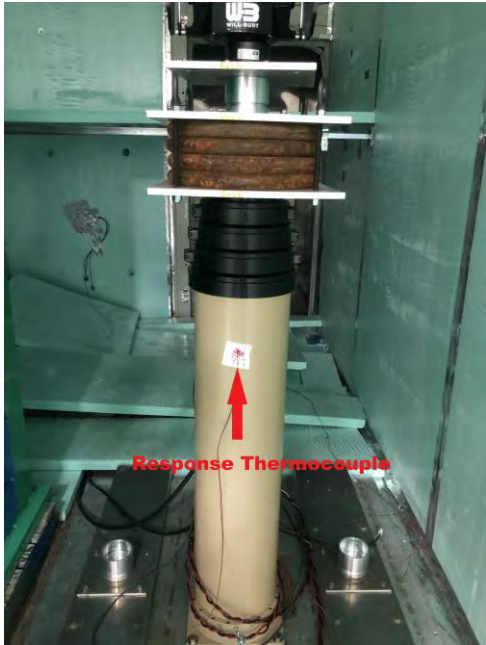
Low Temperature	
	MIL-STD-810G	
	Response Location	
	Unit Tested	Stiletto AL (4 Meter Telescoping Mast)
	Model Number	N/A
	Part Number	N/A
	Serial Number	N/A
	Will-Burt Company	
	Date:	3/28/18 - 3/30/18
	Job #:	1608-019NB-1

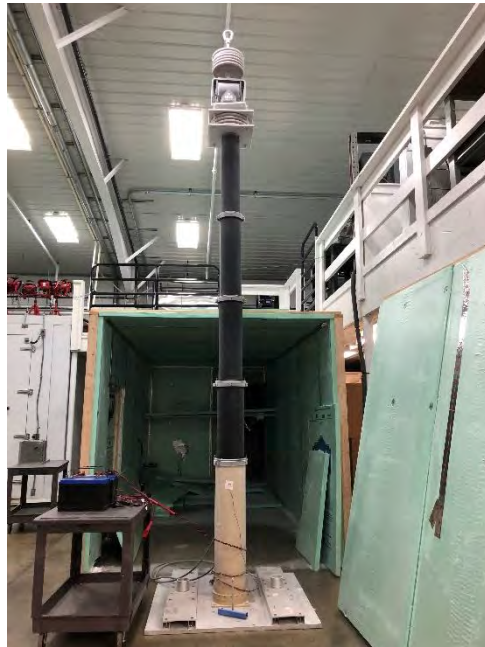
Low Temperature	
MIL-STD-810G	
Post Test Functional Verification	
Unit Tested	Stiletto AL (4 Meter Telescoping Mast)
Model Number	N/A
Part Number	N/A
Serial Number	N/A
Will-Burt Company	
Date:	3/28/18 - 3/30/18
Job #:	1608-019NB-1

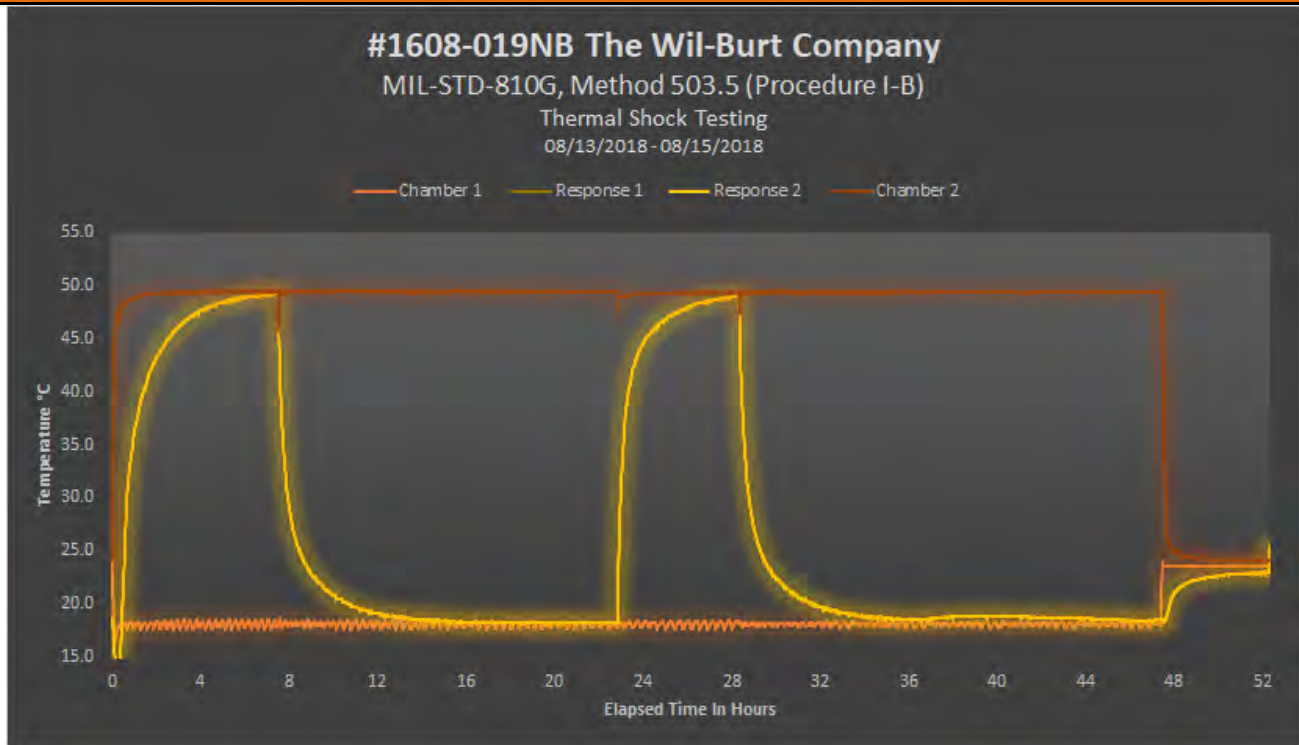
<p>#1608-019NB The Wil-Burt Company MIL-STD-810G, Method 503.5 (Procedure I-B) Thermal Shock Testing 08/13/2018 - 08/15/2018</p> <p>— Chamber 1 — Response 1 — Response 2 — Chamber 2</p> <p>Temperature °C</p> <p>Elapsed Time In Hours</p>									
Environmental Profile Information									
Test Cycle Begins At:	09:12 on 08/13/2018								
Test Cycle Ends At:	13:30 on 08/15/2018								
Target Setpoints:	+18°C to +49°C								
Total Number of Cycles:	2								
Cycle Duration:	TBD								
EUT Test Information			Y	N	N/A	Comments			
Operating During Test:				X		Operating Mode:		N/A

Powered During Test:				X		V	N/A	A	N/A
Physical Damage Noted:				X					
PAGE:	1	ENGINEER/TECHNICIAN(S):		T. Swartz					
OF:	1	TECHNICAL REVIEWER:		R. Turner

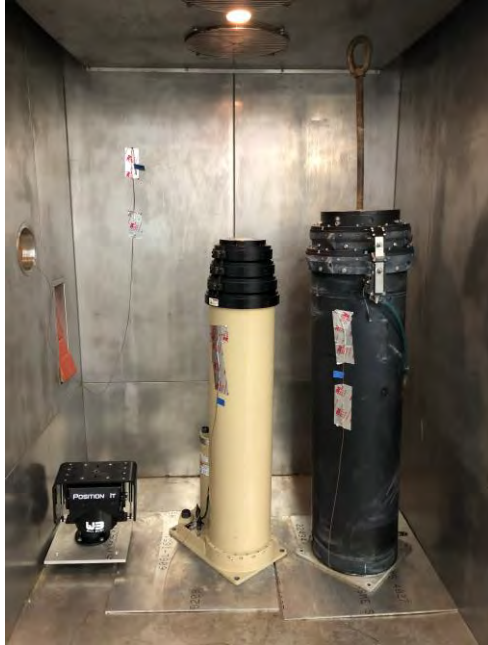
Thermal Shock	
	MIL-STD-810G	
	Test Setup Chamber 1	
	Unit Tested	Stiletto AL (4 Meter Telescoping Mast)
	Model Number	N/A
	Part Number	N/A
	Serial Number	N/A
	Will-Burt Company	
	Date:	8/13/18 - 8/18/18
	Job #:	1608-019NB-1

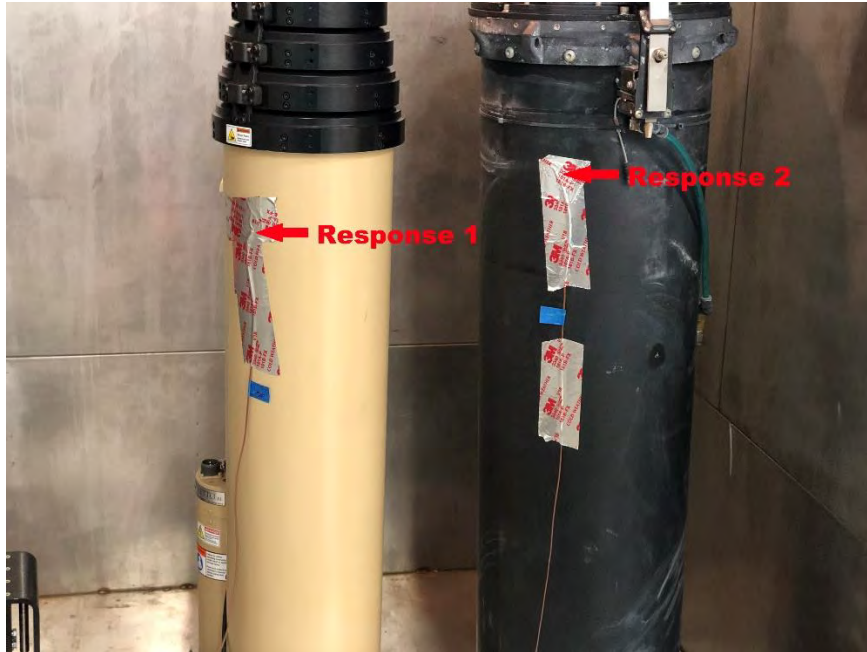
Thermal Shock	
MIL-STD-810G	
Response Location	
Unit Tested	Stiletto AL (4 Meter Telescoping Mast)
Model Number	N/A
Part Number	N/A
Serial Number	N/A
Will-Burt Company	
Date:	8/13/18 - 8/18/18
Job #:	1608-019NB-1

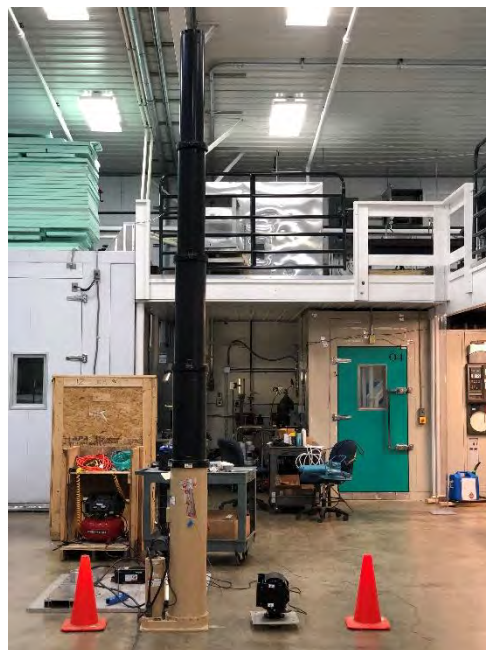
Thermal Shock	
MIL-STD-810G	
Post Test Functional Verification	
Unit Tested	Stiletto AL (4 Meter Telescoping Mast)
Model Number	N/A
Part Number	N/A
Serial Number	N/A
Will-Burt Company	
Date:	8/13/18 - 8/18/18
Job #:	1608-019NB-1

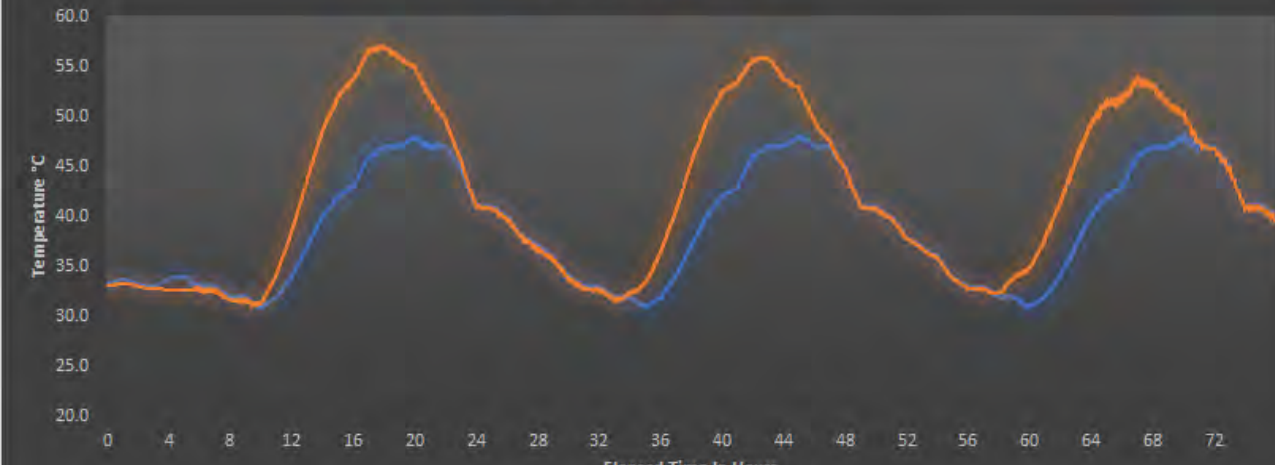
#1608-019NB The Wil-Burt Company MIL-STD-810G Method 505, Procedure I Solar Radiation (Temperature) 07/09/2018 - 07/12/2018 Chamber Air UUT Response

Environmental Profile Information					
Test Cycle Begins At:	09:28 on 07/10/2018				
Test Cycle Ends At:	13:26 on 07/13/2018				
Total Number of Cycles:	3				
Test Duration:	72 hrs.				
Category:	A1				
EUT Test Information	Y	N	N/A	Comments	
Operating During Test:		X		Operating Mode:	N/A
Powered During Test:		X		V	A AC/DC
Physical Damage Noted:		X			
PAGE: 1	ENGINEER/TECHNICIAN(S): T. Swartz				
OF: 1	TECHNICAL REVIEWER: R. Turner

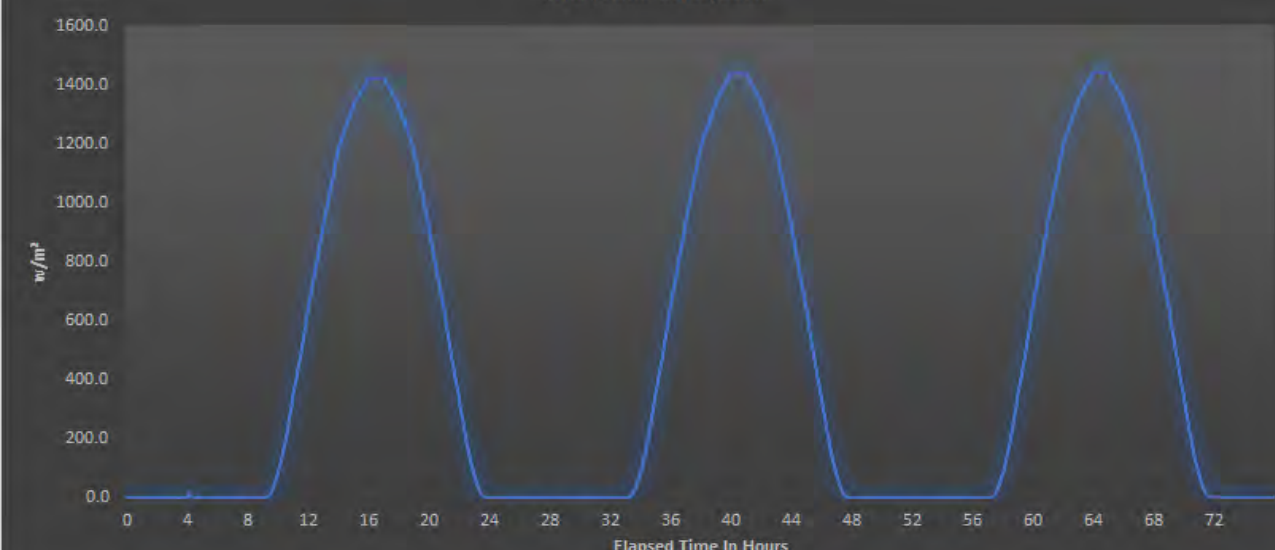
Solar Radiation Data Sheet					
EUT:	Stiletto AL (4 Meter Telescoping Mast)			Job Number:	1608-019NB-1
M/N:	N/A	P/N:	N/A	S/N:	N/A
Customer:	Will-Burt Company				
Date:	7/10/18 - 7/13/18			Test Engineer:	T. Swartz
Test Specifications					
Test Spec:	MIL-STD-810G			Para./Sec.:	505.1
Solar Load Profile					
#1608-019NB The Wil-Burt Company MIL-STD-810G Method 505, Procedure I Solar Radiation (Solar Load) 07/09/2018 - 07/12/2018

Environmental Profile Information					
Test Cycle Begins At:	09:28 on 07/10/2018				
Test Cycle Ends At:	13:26 on 07/13/2018				
Total Number of Cycles:	3				
Test Duration:	72 hrs.				
Category:	A1				
EUT Test Information	Y	N	N/A	Comments	
Operating During Test:		X		Operating Mode:	N/A
Powered During Test:		X		V	A AC/DC
Physical Damage Noted:		X			
PAGE: 1	ENGINEER/TECHNICIAN(S): T. Swartz				
OF: 1	TECHNICAL REVIEWER: R. Turner

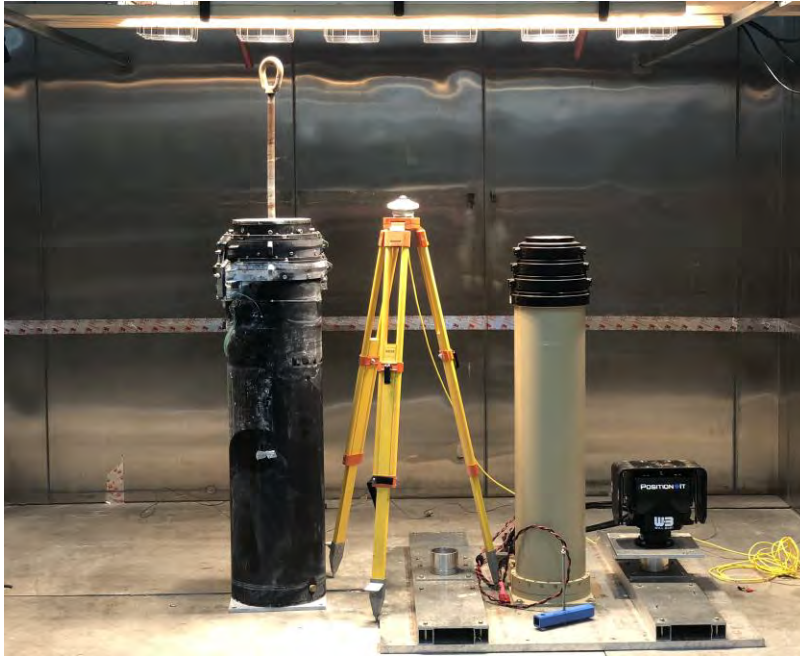
Solar Radiation	
MIL-STD-810G	
Test Setup	
Unit Tested	Stiletto AL (4 Meter Telescoping Mast)
Model Number	N/A
Part Number	N/A
Serial Number	N/A
Will-Burt Company	
Date:	7/10/18 - 7/13/18
Job #:	1608-019NB-1

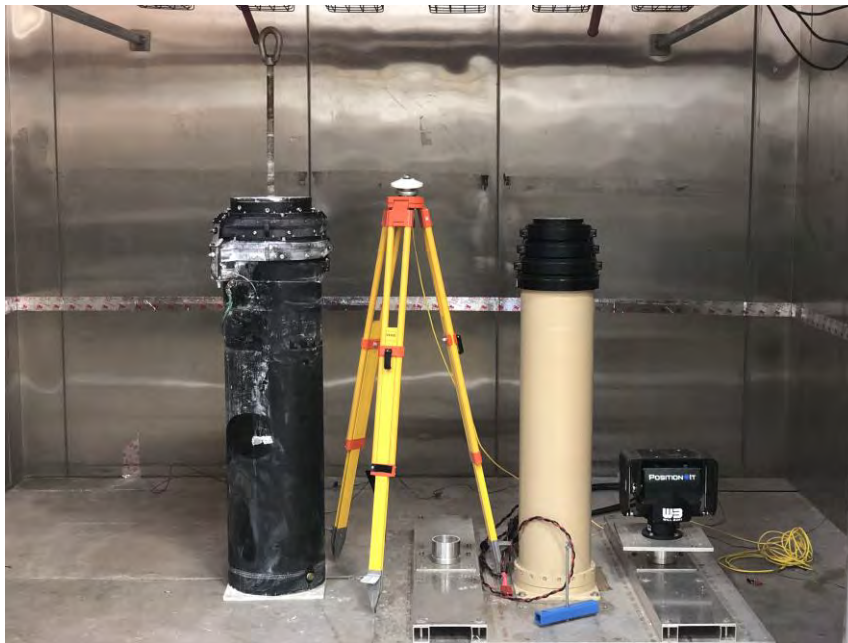
Solar Radiation	
MIL-STD-810G	
Post Test Pre-Inspection	
Unit Tested	Stiletto AL (4 Meter Telescoping Mast)
Model Number	N/A
Part Number	N/A
Serial Number	N/A
Will-Burt Company	
Date:	7/10/18 - 7/13/18
Job #:	1608-019NB-1

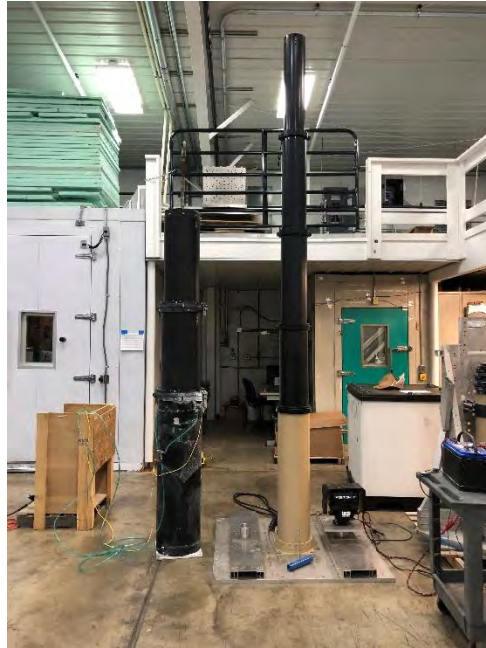
Solar Radiation	
MIL-STD-810G	
Post Test Functional Verification	
Unit Tested	Stiletto AL (4 Meter Telescoping Mast)
Model Number	N/A
Part Number	N/A
Serial Number	N/A
Will-Burt Company	
Date:	7/10/18 - 7/13/18
Job #:	1608-019NB-1

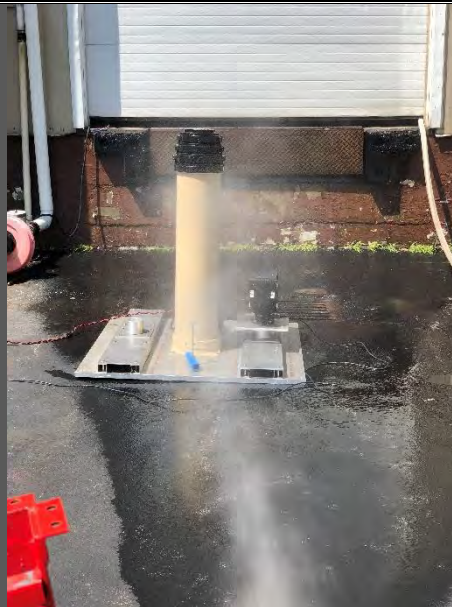
Rain Flow(kPa):	5" per Hour						
Wind Speed:(mph):	40						
Sides Tested:	4						
Duration:	30 minutes						
EUT Test Information	Y	N	N/A	Comments			
Operating During Test:	X			Operating Mode:	Unit was operated for the last 10 minutes of each side tested.		
Powered During Test:	X			V	N/A	A	N/A
Physical Damage Noted:		X					
Water Ingress Noted:		X

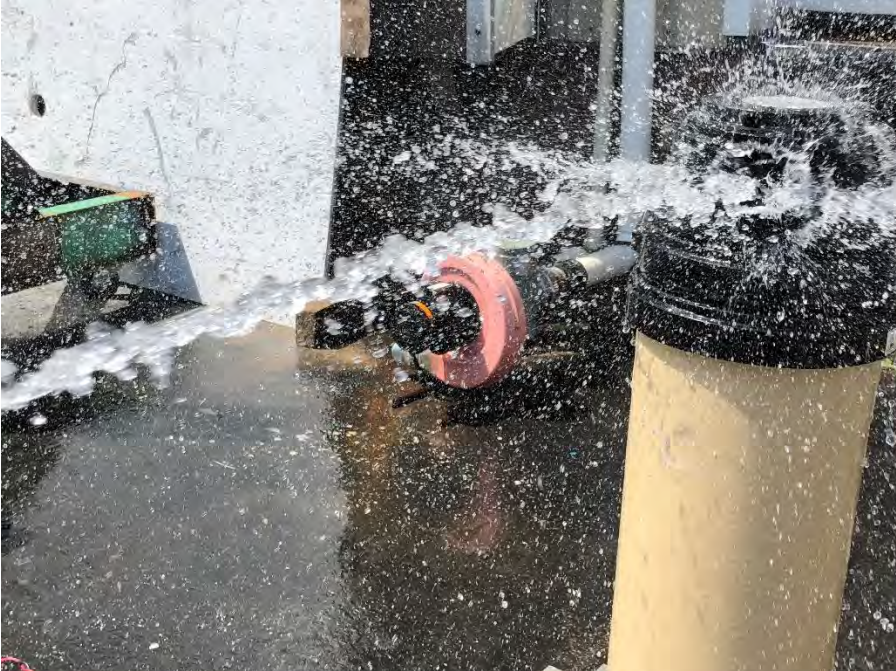
Rain	
		MIL-STD-810G	
		Rain Test Setup	
Unit Tested		Stiletto AL (4 Meter Telescoping Mast)	
Model Number		N/A	
Part Number		N/A	
Serial Number		N/A	
		Will-Burt Company	
Date:		7/17/18	
Job #:		1608-019NB-1

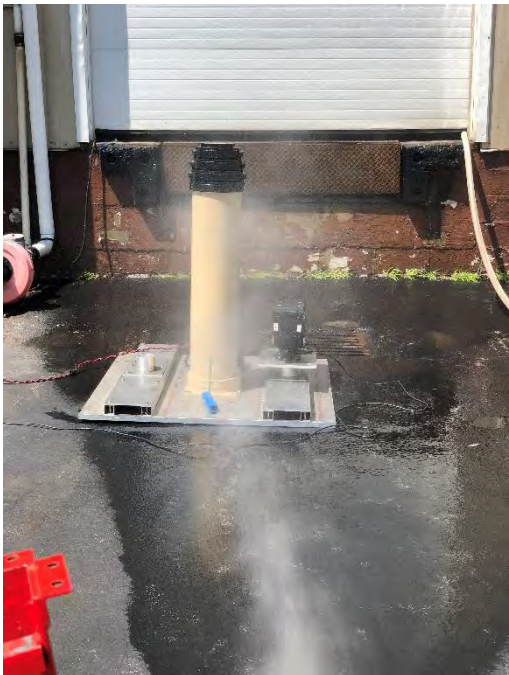
Rain	
		MIL-STD-810G	
		Blowing Rain Test Setup	
Unit Tested		Stiletto AL (4 Meter Telescoping Mast)	
Model Number		N/A	
Part Number		N/A	
Serial Number		N/A	
		Will-Burt Company	
Date:		7/17/18	
Job #:		1608-019NB-1

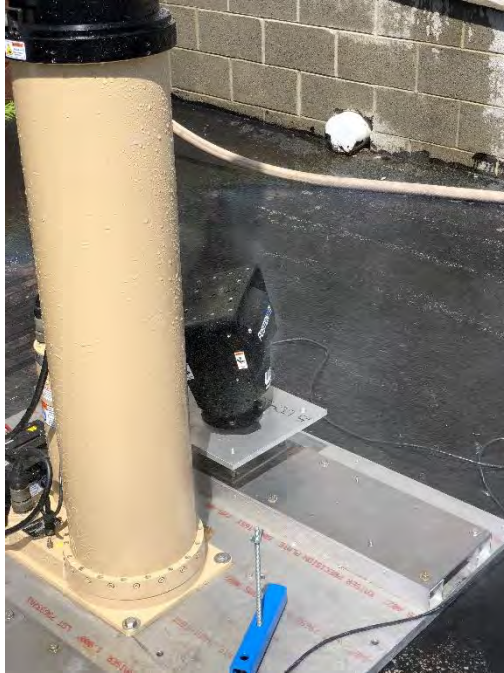
3.7	Rain	No obvious signs of damage to Stiletto AL (4 Meter Telescoping Mast), due to Rain testing conditions. Stiletto AL (4 Meter Telescoping Mast) met the criteria of the specification.
0	HUMIDITY	No obvious signs of damage to Stiletto AL (4 Meter Telescoping Mast), due to HUMIDITY testing conditions. Stiletto AL (4 Meter Telescoping Mast) met the criteria of the specification.

Rain	
MIL-STD-810G	
Post Test Inspection	
Unit Tested	Stiletto AL (4 Meter Telescoping Mast)
Model Number	N/A
Part Number	N/A
Serial Number	N/A
Will-Burt Company	
Date:	7/17/18
Job #:	1608-019NB-1

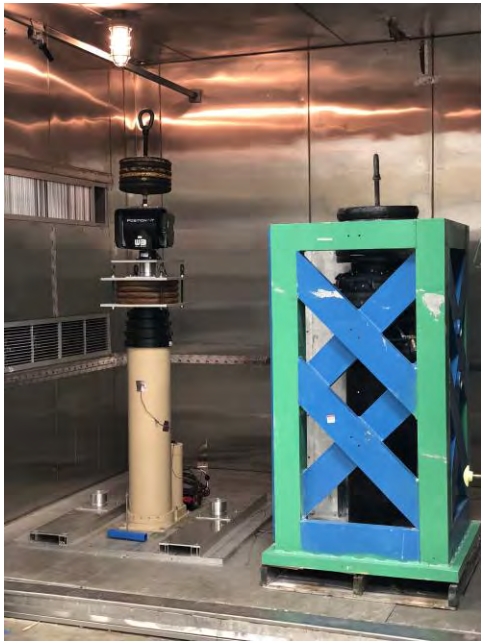
HUMIDITY	
		MIL-STD-810G	
		Post Test	
Unit Tested		Stiletto AL (4 Meter Telescoping Mast)	
Model Number		N/A	
Part Number		N/A	
Serial Number		N/A	
		Will-Burt Company	
Date:		6/29/18 - 7/9/18	
Job #:		1608-019NB-1

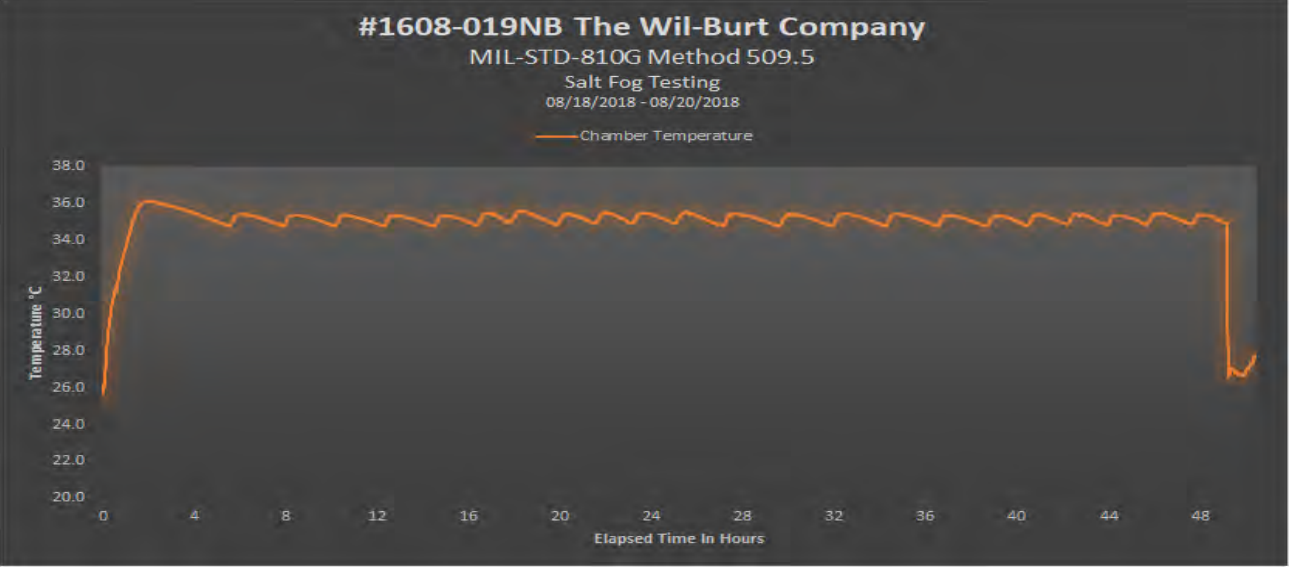
#1608-019NB The Wil-Burt Company MIL-STD-810G Method 509.5 Salt Fog Testing 08/18/2018 - 08/20/2018 Chamber Temperature

Test Cycle Begins At:	14:37 on 08/18/2018										
Test Cycle Ends At:	17:04 on 08/20/2018										
Samples Tested:	2										
Total Number of Cycles:	1										
Spray Duration:	48:00:00										
Post Spray Drying Duration:	48:00:00										
Salt Solution:	5%										
Temperature:	35°C										
Specific Gravity (g/cm ³):	1.030g/cm³										
pH Level:	6.8										
Fallout Rate (Per Hour):	1.69ml/hr										
Air Pressure:	16.75 psi										
EUT Test Information			Y	N	N/A	Comments					
Operating During Test:				X		Operating Mode:	Non-Operating				
Powered During Test:				X		V	N/A	A	N/A	AC/DC	N/A
PAGE: 1	ENGINEER/TECHNICIAN(S): T. Swartz										
OF: 1	TECHNICAL REVIEWER: R. Turner

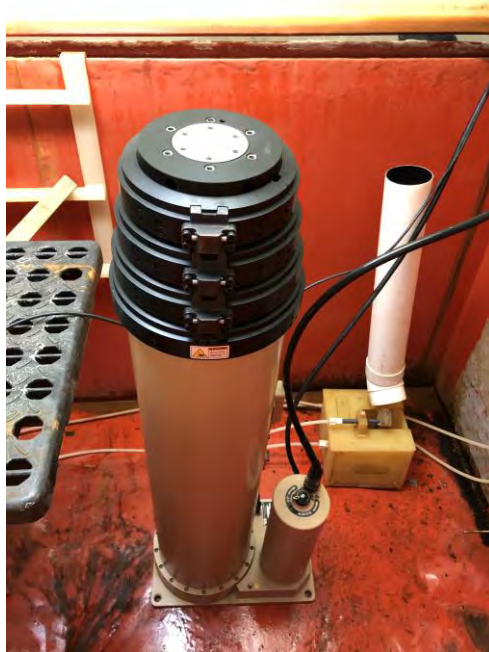
Salt Fog	
MIL-STD-810G	
Test Setup	
Unit Tested	Stiletto AL (4 Meter Telescoping Mast)
Model Number	N/A
Part Number	N/A
Serial Number	N/A
Will-Burt Company	
Date:	8/18/18 - 9/4/18
Job #:	1608-019NB-1

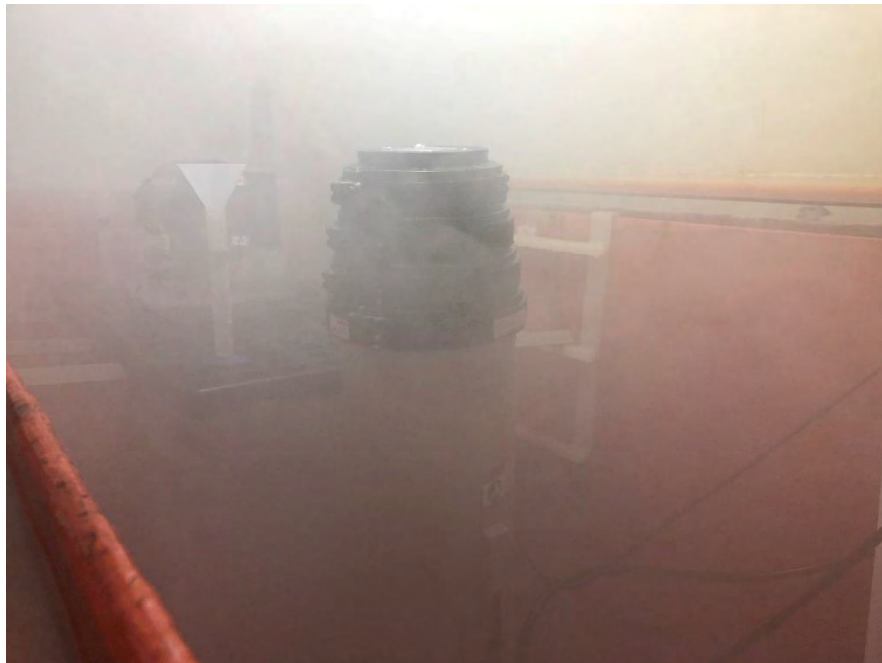
Salt Fog	
MIL-STD-810G	
Post Test (Pre-Drying)	
Unit Tested	Stiletto AL (4 Meter Telescoping Mast)
Model Number	N/A
Part Number	N/A
Serial Number	N/A
Will-Burt Company	
Date:	8/18/18 - 9/4/18
Job #:	1608-019NB-1

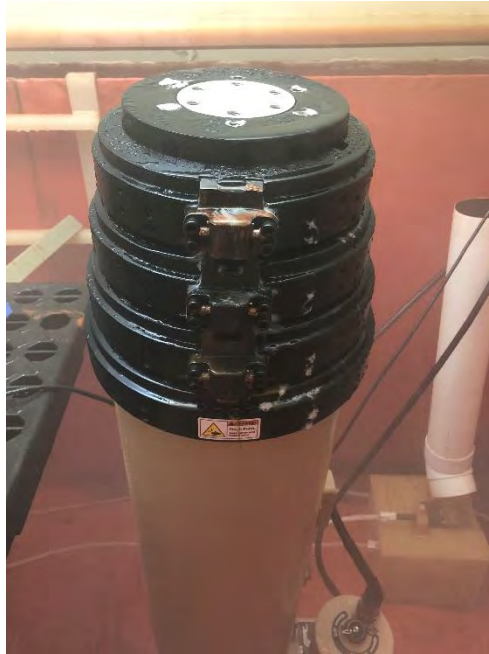
Salt Fog	
MIL-STD-810G	
Post Test (Pre-Drying)	
Unit Tested	Stiletto AL (4 Meter Telescoping Mast)
Model Number	N/A
Part Number	N/A
Serial Number	N/A
Will-Burt Company	
Date:	8/18/18 - 9/4/18
Job #:	1608-019NB-1

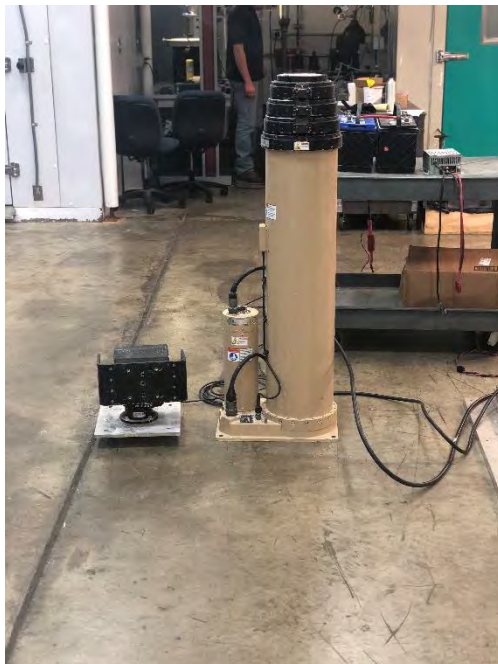
Salt Fog	
MIL-STD-810G	
Post Test Functional Verification	
Unit Tested	Stiletto AL (4 Meter Telescoping Mast)
Model Number	N/A
Part Number	N/A
Serial Number	N/A
Will-Burt Company	
Date:	8/18/18 - 9/4/18
Job #:	1608-019NB-1

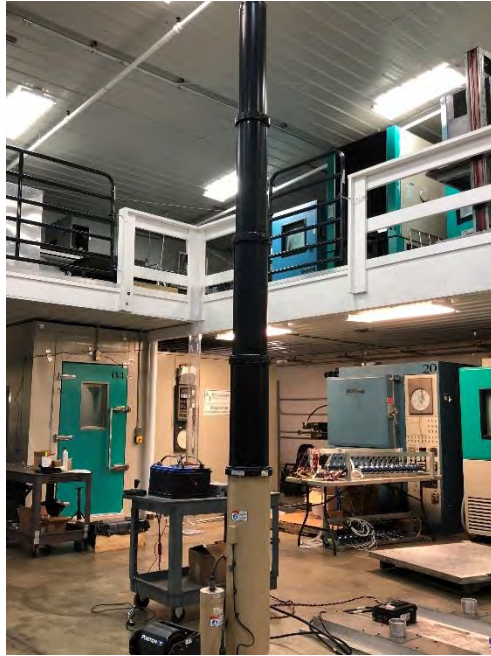
Salt Fog	
MIL-STD-810G	
Post Test Functional Verification	
Unit Tested	Stiletto AL (4 Meter Telescoping Mast)
Model Number	N/A
Part Number	N/A
Serial Number	N/A
Will-Burt Company	
Date:	8/18/18 - 9/4/18
Job #:	1608-019NB-1

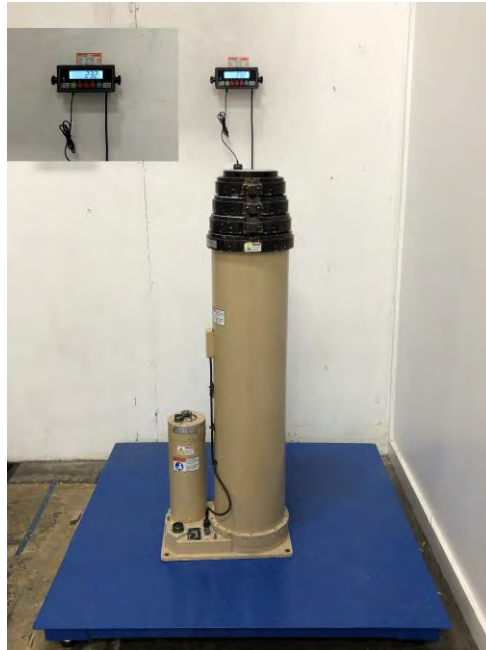
Shock	
MIL-STD-810G	
Test Verification	
Unit Tested	Stiletto AL (4 Meter Telescoping Mast)
Model Number	N/A
Part Number	N/A
Serial Number	N/A
Will-Burt Company	
Date:	8/21/18
Job #:	1608-019NB-1

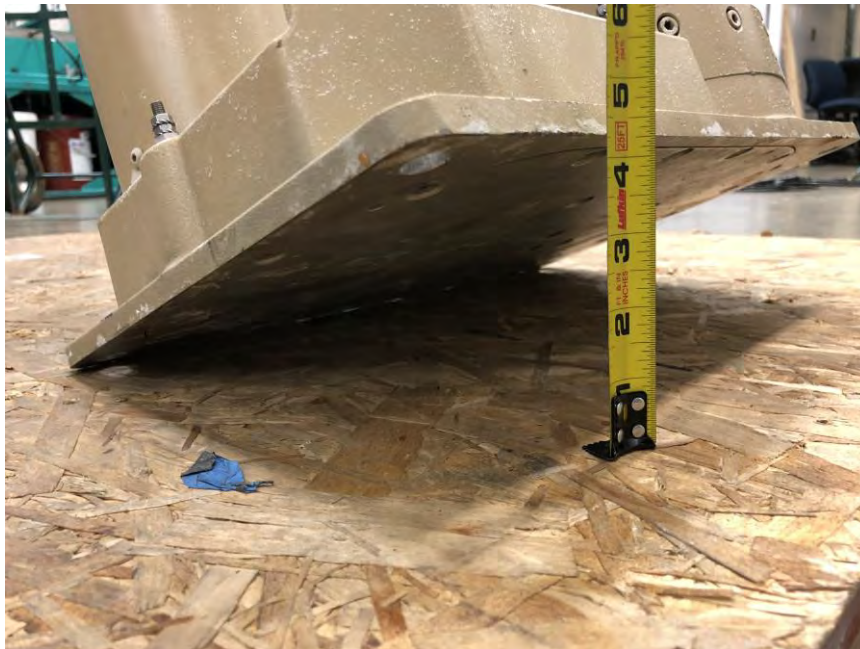
Shock	
MIL-STD-810G	
Bench Handling Verification	
Unit Tested	Stiletto AL (4 Meter Telescoping Mast)
Model Number	N/A
Part Number	N/A
Serial Number	N/A
Will-Burt Company	
Date:	8/21/18
Job #:	1608-019NB-1

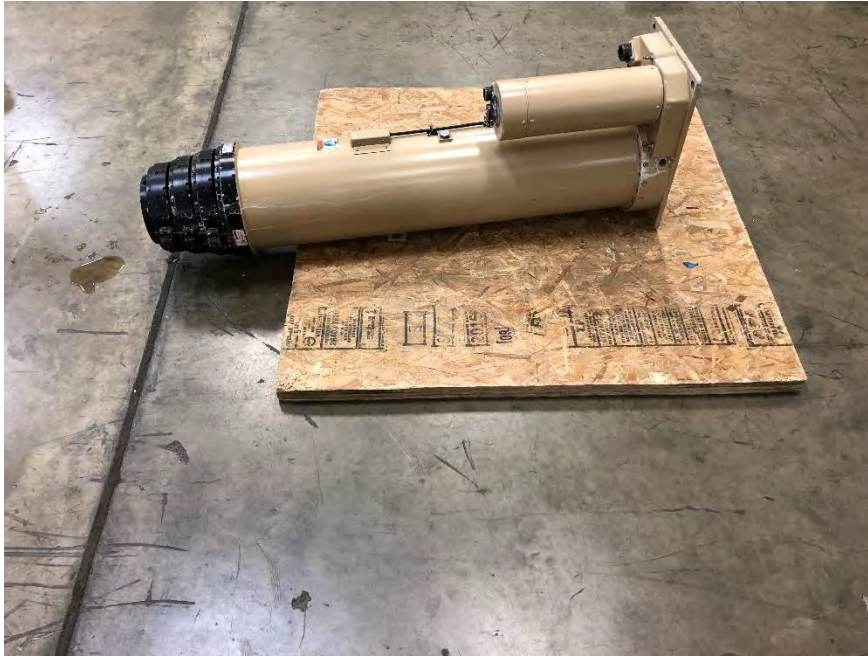
Shock	
MIL-STD-810G	
Post Bench Handling	
Unit Tested	Stiletto AL (4 Meter Telescoping Mast)
Model Number	N/A
Part Number	N/A
Serial Number	N/A
Will-Burt Company	
Date:	8/21/18
Job #:	1608-019NB-1

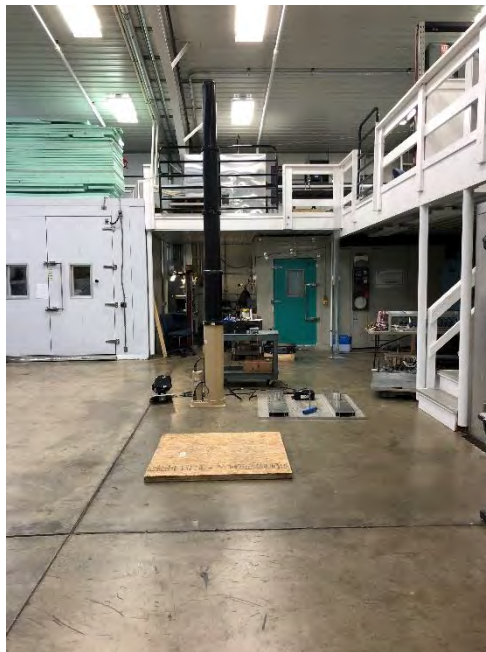
Shock	
MIL-STD-810G	
Post Bench Handling Functional Verification	
Unit Tested	Stiletto AL (4 Meter Telescoping Mast)
Model Number	N/A
Part Number	N/A
Serial Number	N/A
Will-Burt Company	
Date:	8/21/18
Job #:	1608-019NB-1

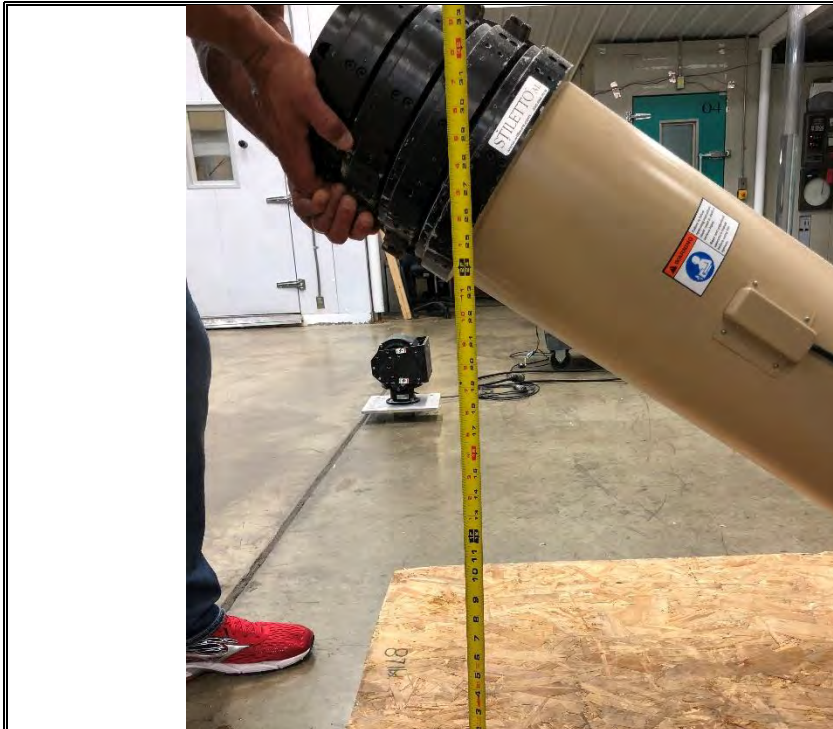
Shock	
MIL-STD-810G	
Transit Drop Verification	
Unit Tested	Stiletto AL (4 Meter Telescoping Mast)
Model Number	N/A
Part Number	N/A
Serial Number	N/A
Will-Burt Company	
Date:	8/21/18
Job #:	1608-019NB-1
