ENVIRONMENTAL TEST REPORT 1608-019NB-1 REV. N/C

TEST STANDARDS: MIL-STD-810G

STILETTO AL (4 METER TELESCOPING MAST)

PERFORMED BY: KEYSTONE COMPLIANCE, LLC.
131 COLUMBUS INNER BELT
NEW CASTLE, PA 16101

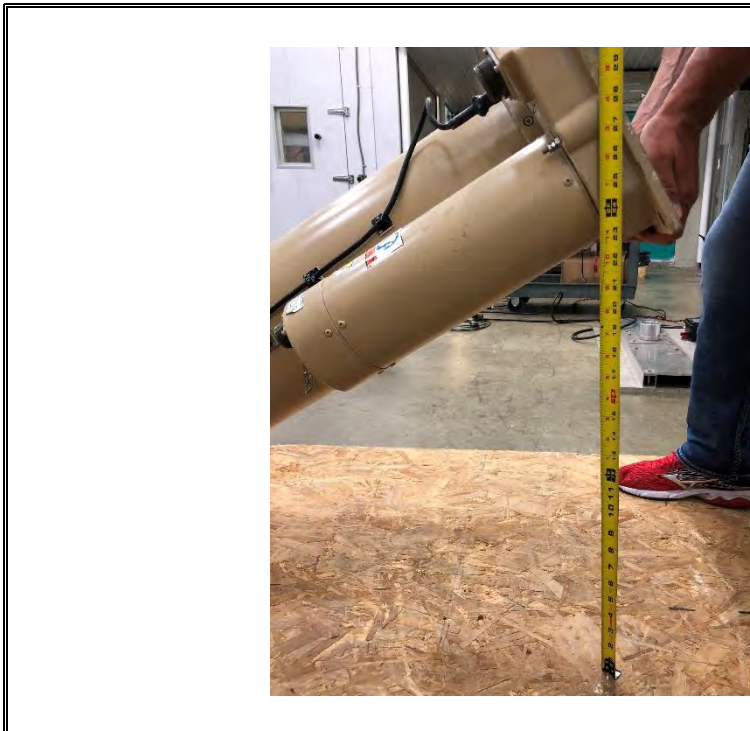
Shock	
MIL-STD-810G	
Transit Drop Verification	
Unit Tested	Stiletto AL (4 Meter Telescoping Mast)
Model Number	N/A
Part Number	N/A
Serial Number	N/A
Will-Burt Company	
Date:	8/21/18
Job #:	1608-019NB-1

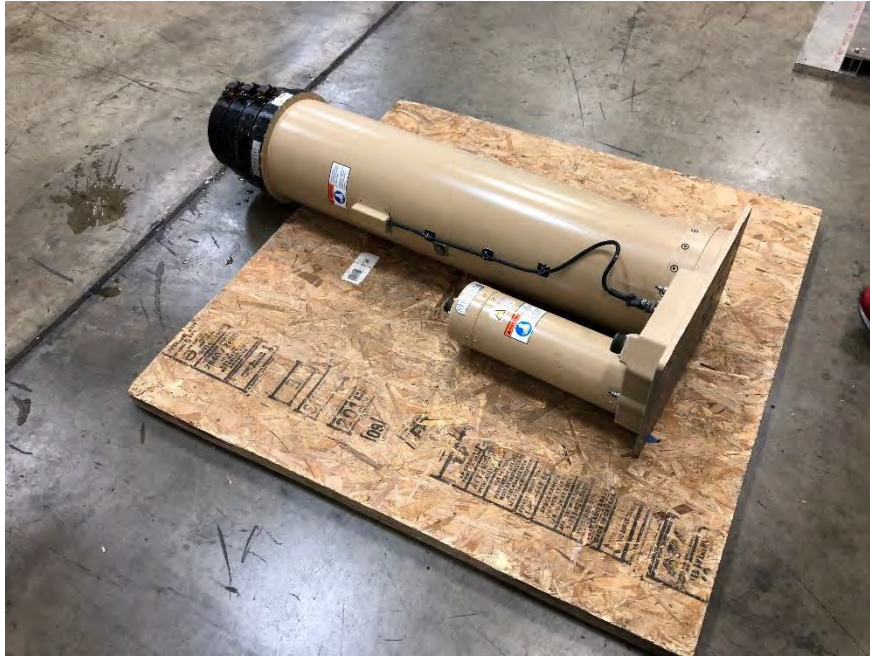
Shock	
MIL-STD-810G	
Post Transit Drop	
Unit Tested	Stiletto AL (4 Meter Telescoping Mast)
Model Number	N/A
Part Number	N/A
Serial Number	N/A
Will-Burt Company	
Date:	8/21/18
Job #:	1608-019NB-1

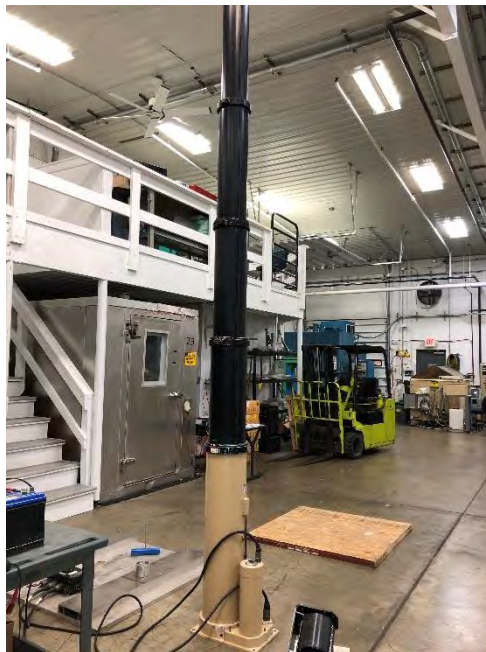
Shock	
MIL-STD-810G	
Post Transit Drop Functional Verification	
Unit Tested	Stiletto AL (4 Meter Telescoping Mast)
Model Number	N/A
Part Number	N/A
Serial Number	N/A
Will-Burt Company	
Date:	8/21/18
Job #:	1608-019NB-1

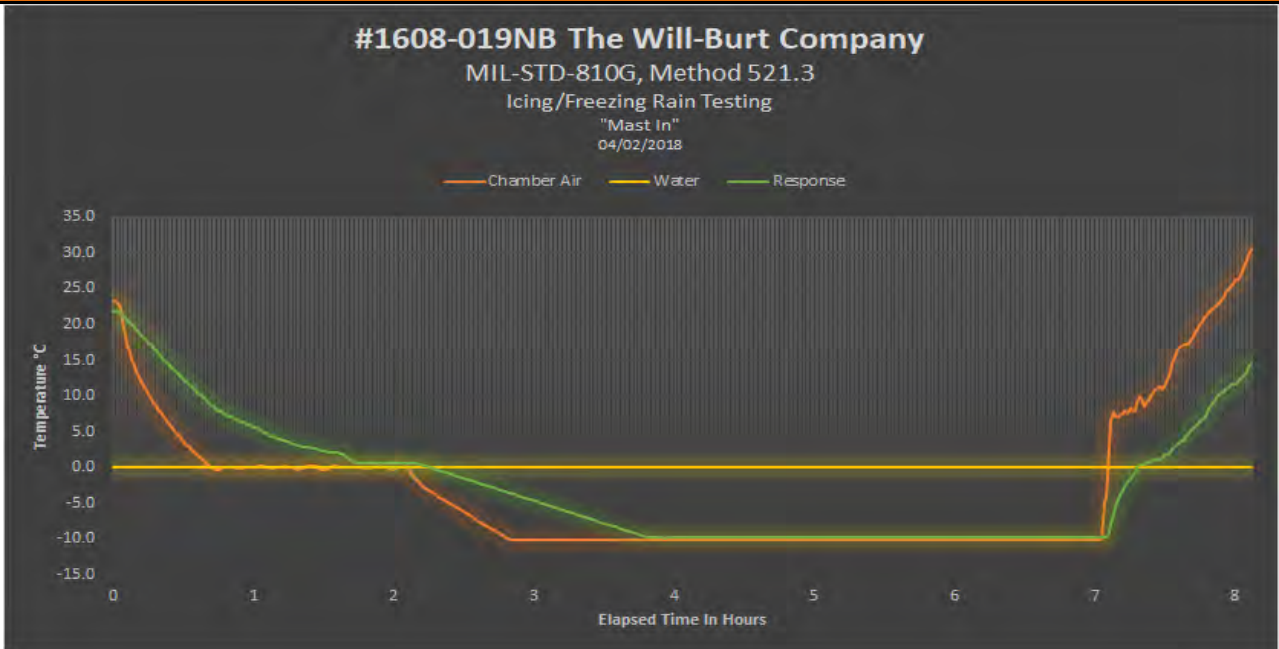
<p>#1608-019NB The Will-Burt Company MIL-STD-810G, Method 521.3 Icing/Freezing Rain Testing "Mast In" 04/02/2018</p> <p>— Chamber Air — Water — Response</p>							
Environmental Profile Information							
Test Cycle Begins At:	08:22 on 04/03/2018						
Test Cycle Ends At:	16:29 on 04/03/2018						
Total Number of Cycles:	1						
Recommended Ice Thickness:	1/4"						
Actual Ice thickness (build up):	3/8"						
Water Temperature:	0.1°C						
Water Delivery Rate:	25 mm/h						
Ice Developed:	Glazed						
EUT Test Information	Y	N	N/A	Comments			
Operating During Test:	Y			Operating Mode:	Powered On for functional evaluation.

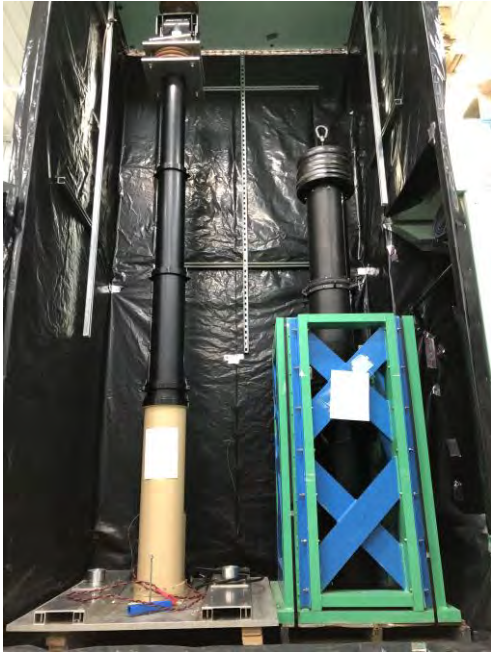
Icing/Freezing Rain	
	MIL-STD-810G	
	Test Setup (Mast Extended)	
	Unit Tested	Stiletto AL (4 Meter Telescoping Mast)
	Model Number	N/A
	Part Number	N/A
	Serial Number	N/A
	Will-Burt Company	
	Date:	4/2/18 - 4/3/18
	Job #:	1608-019NB-1

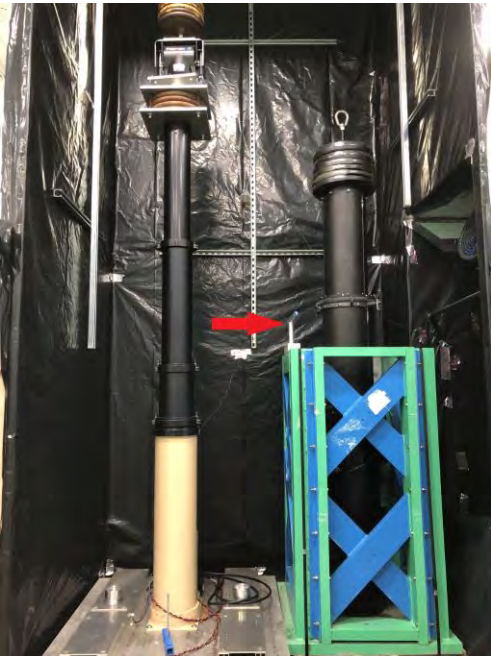
Icing/Freezing Rain	
	MIL-STD-810G	
	Verification Location (Mast Extended)	
	Unit Tested	Stiletto AL (4 Meter Telescoping Mast)
	Model Number	N/A
	Part Number	N/A
	Serial Number	N/A
	Will-Burt Company	
	Date:	4/2/18 - 4/3/18
	Job #:	1608-019NB-1

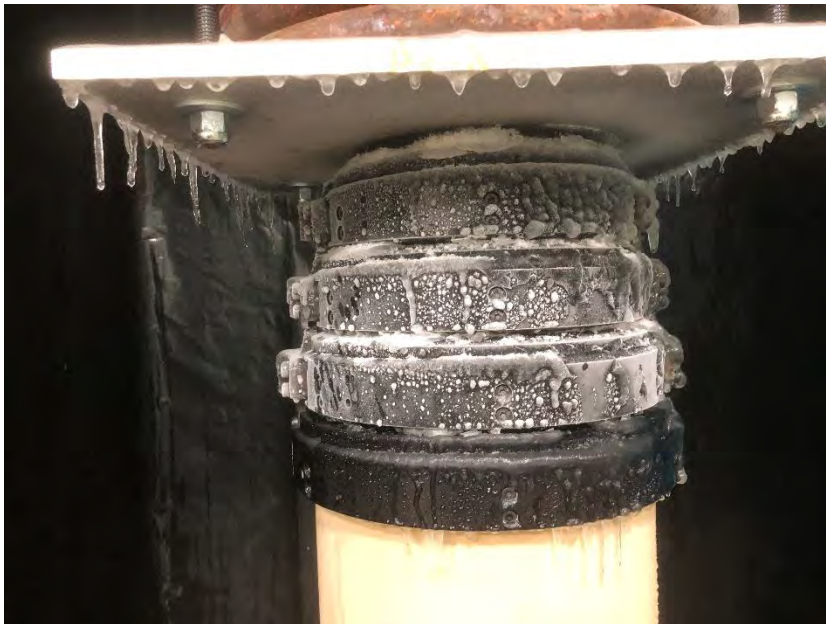
Icing/Freezing Rain	
MIL-STD-810G	
Post Test Functional Verification (Mast Extended)	
Unit Tested	Stiletto AL (4 Meter Telescoping Mast)
Model Number	N/A
Part Number	N/A
Serial Number	N/A
Will-Burt Company	
Date:	4/2/18 - 4/3/18
Job #:	1608-019NB-1

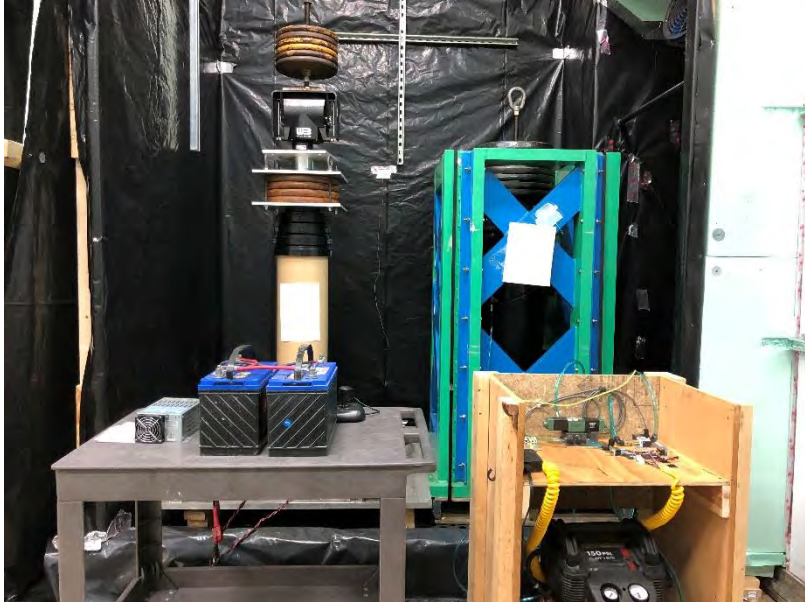
Icing/Freezing Rain	
	MIL-STD-810G	
	Test Setup (Mast In)	
	Unit Tested	Stiletto AL (4 Meter Telescoping Mast)
	Model Number	N/A
	Part Number	N/A
	Serial Number	N/A
	Will-Burt Company	
	Date:	4/2/18 - 4/3/18
	Job #:	1608-019NB-1

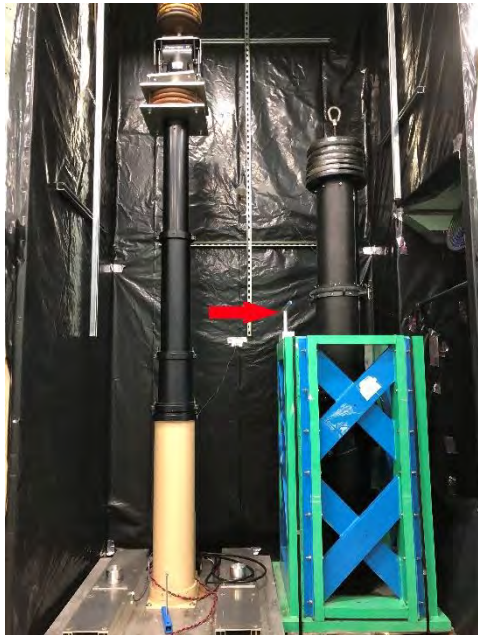
Icing/Freezing Rain	
	MIL-STD-810G	
	Verification Location (Mast In)	
	Unit Tested	Stiletto AL (4 Meter Telescoping Mast)
	Model Number	N/A
	Part Number	N/A
	Serial Number	N/A
	Will-Burt Company	
	Date:	4/2/18 - 4/3/18
	Job #:	1608-019NB-1

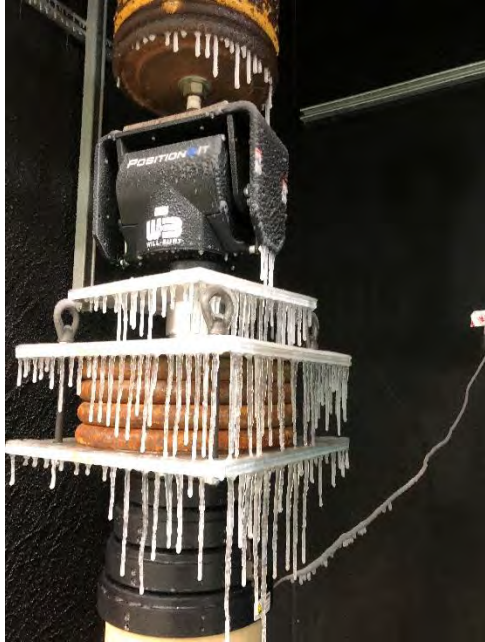
11:25	3	1/4" of ice was produced
	15:25	3	Operated the UUT's
	15:55	3	Ramped back to ambient (23°C)
	16:00	3	Stabilized at ambient
			<i>Test Complete. A post-test functional test was performed, and there were no anomalies noted. Upon inspection of the units there were no signs of damage, or deterioration resulting from the performed testing.</i>
Icing / Freezing Rain Testing (MIL-STD-810G, Method 521.3) Mast In

Icing/Freezing Rain	
	MIL-STD-810G	
	Icing Verification (Mast In)	
	Unit Tested	Stiletto AL (4 Meter Telescoping Mast)
	Model Number	N/A
	Part Number	N/A
	Serial Number	N/A
	Will-Burt Company	
	Date:	4/2/18 - 4/3/18
Job #:	1608-019NB-1

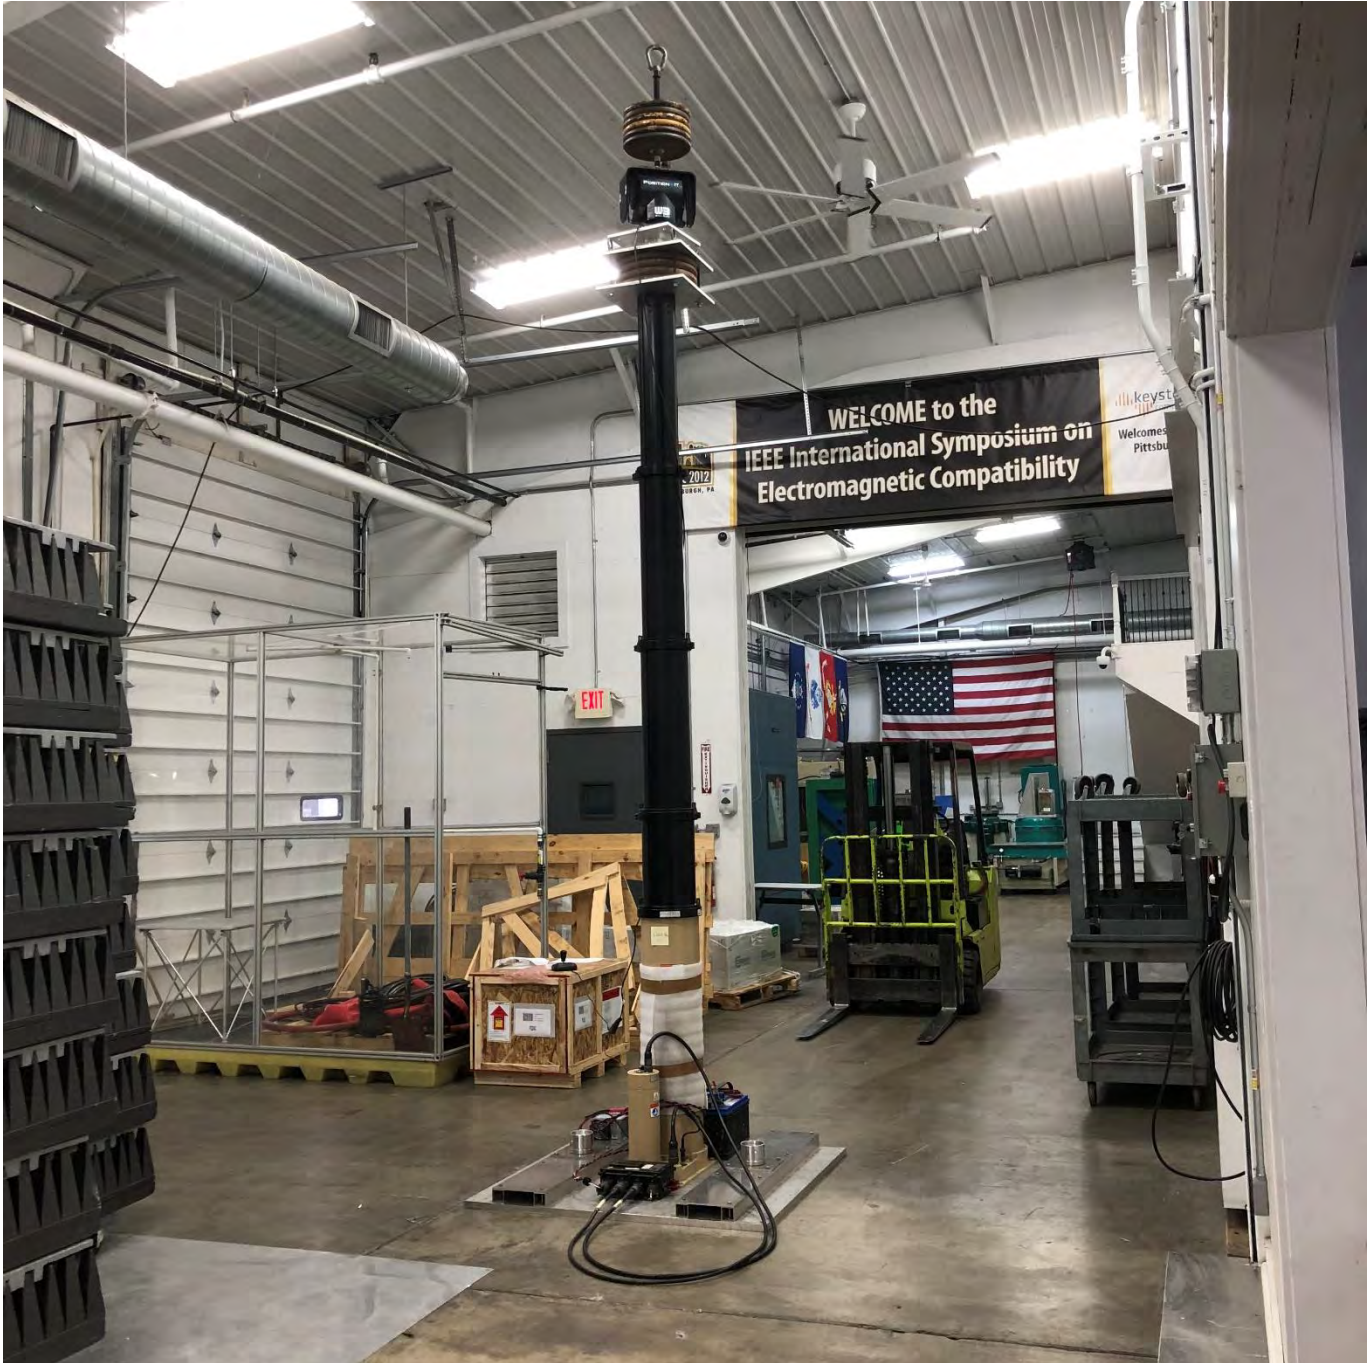
APPENDIX A
PRE-TEST FUNCTIONAL VERIFICATION PHOTO

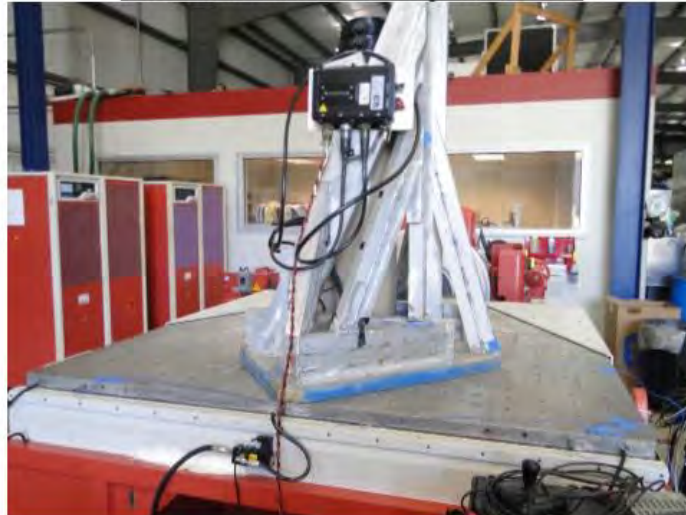
Photo 5.2.1-2: EUT 1 Longitudinal Axis

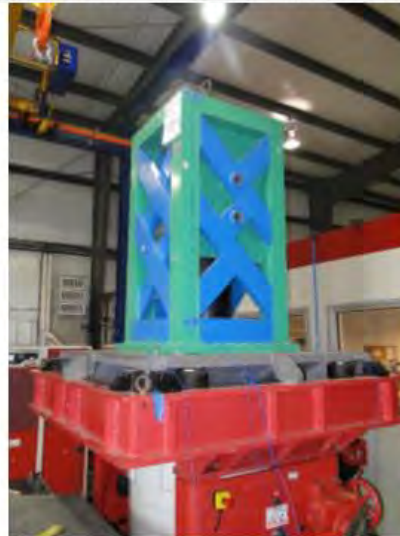
Photo 5.2.1-4: EUT 2 Vertical Axis

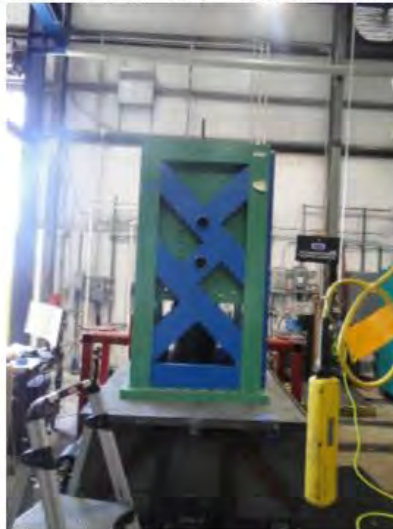
Photo 5.2.1-5: EUT 2 Transverse Axis

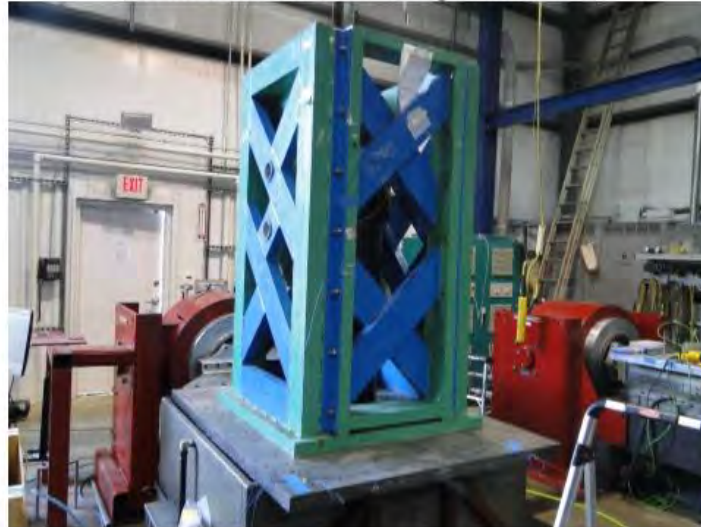
Photo 5.2.1-6: EUT 2 Longitudinal Axis

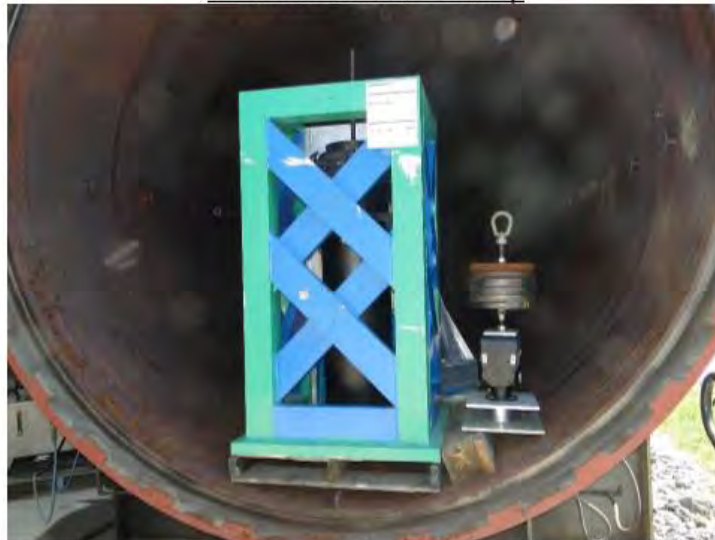
Photo 5.2.2-2: Test Setup

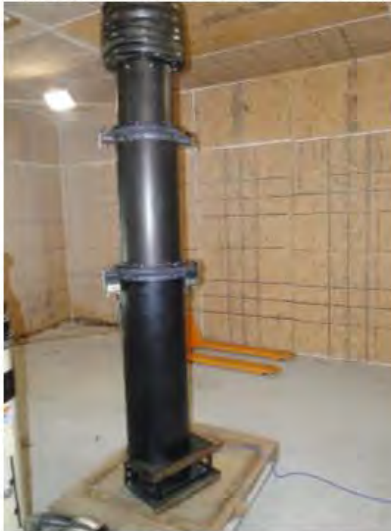
Photo 5.2.3-1: Side #1 EUT 2

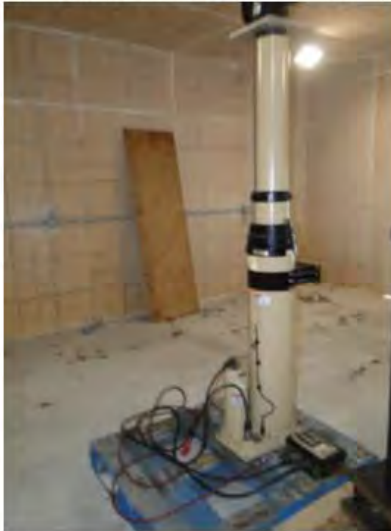
Photo 5.2.3-2: Side #1 EUT 1

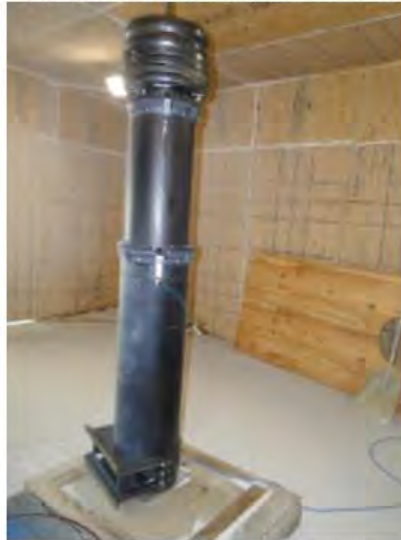
Photo 5.2.3-3: Side #2 EUT 2

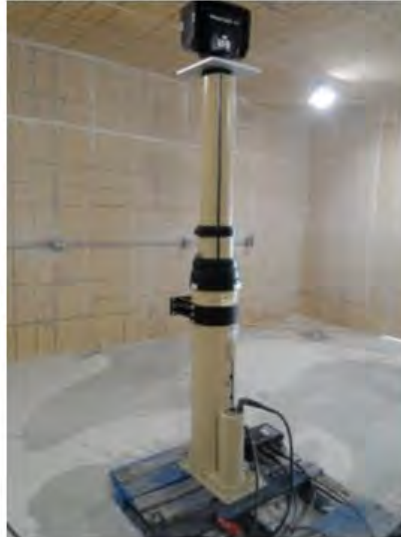
Photo 5.2.3-4: Side #2 EUT 1

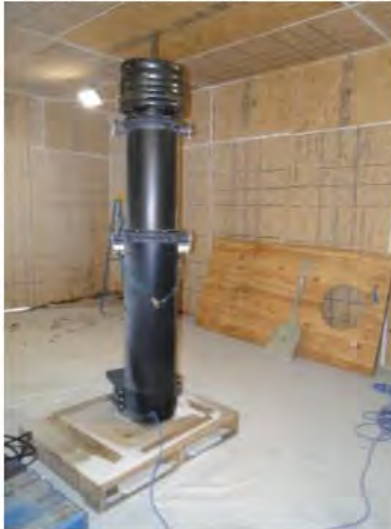
Photo 5.2.3-5: Side #3 EUT 2

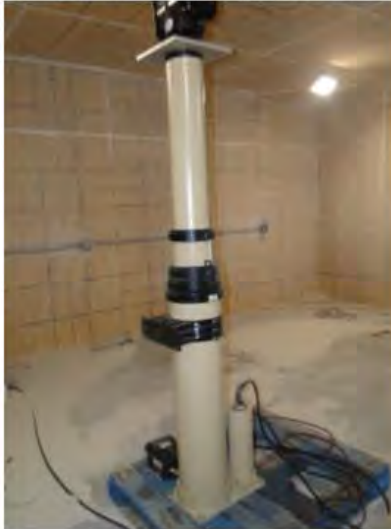
Photo 5.2.3-6: Side #3 EUT 1

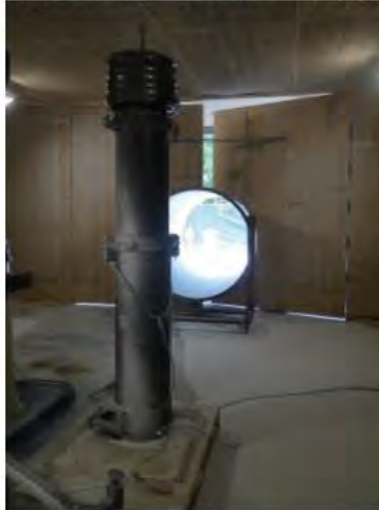
Photo 5.2.3-7: Side #4 EUT 2

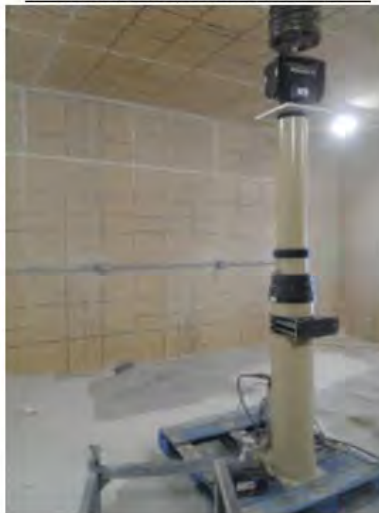
Photo 5.2.3-8: Side #4 EUT 1

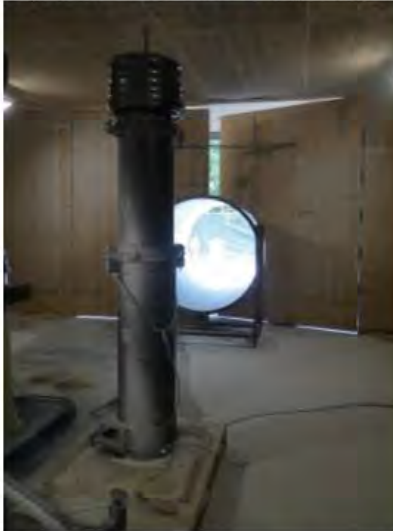
Photo 5.2.4-1: Test Setup EUT #2

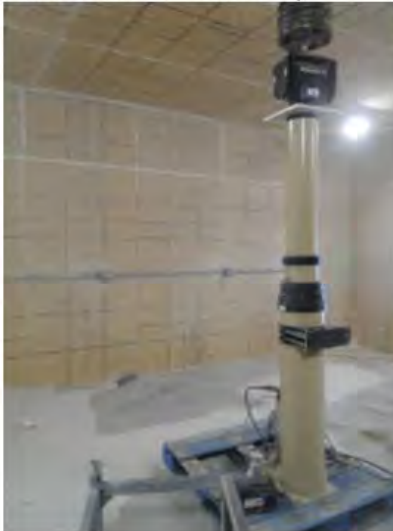
Photo 5.2.4-2: Test Setup EUT #1

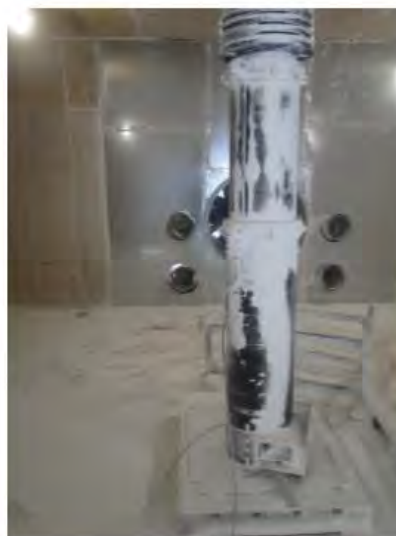
Photo 5.2.4-4: Post Test EUT #2

The EUT showed no signs of damage as a result of testing and operated as intended afterwards.

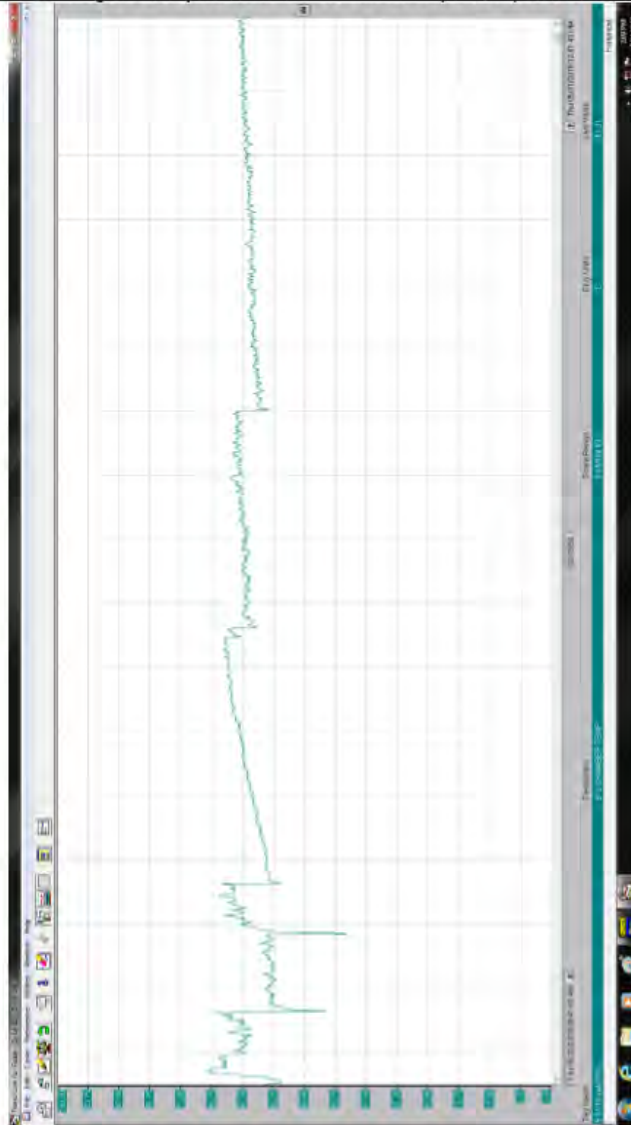
Chart 5.2.4-9: High Temperature Low Wind Speed (Remaining 2 hours)

- A) Six hours
 - a. 1735 feet/minute air velocity
 - b. Ambient temperature
- B) Sixteen hours
 - a. 300 feet/minute air velocity
 - b. 60°C
- C) Six hours
 - a. 1735 feet/minute air velocity
 - b. 60°C
- D) 10.6g/m³ dust concentration
- E) <30% relative humidity
- F) Masts extended as much as chamber will allow
